SHIRE OF WOODANILLING

SPECIAL MEETING OF COUNCIL Agenda 2 June 2020

A Special Council Meeting has been called by resolution of Council for 4pm on 2 June 2020 at the Recreation Pavilion on Yairabin Street Woodanilling. The purpose of the meeting is to consider the Feedlot Development Application for Lots 1 & 4 Youngs Road Beaufort River.

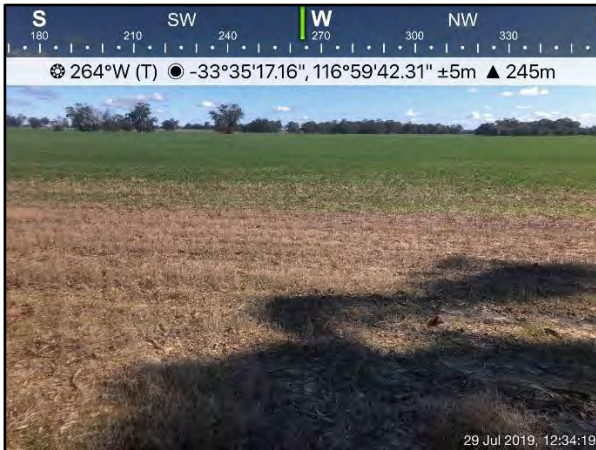
Photograph 1: View to the west across cleared Subject Site.

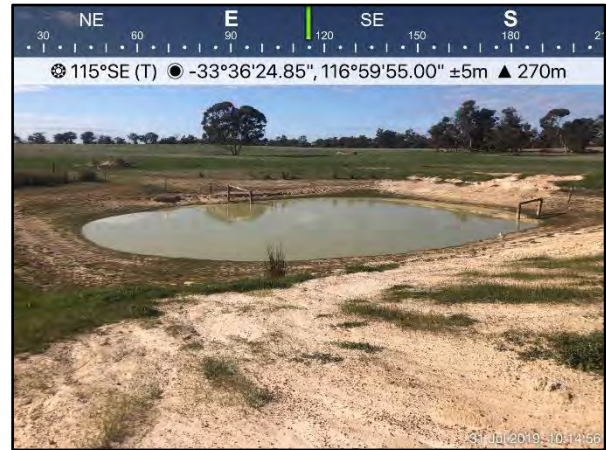
Photograph 2: View of dam at low point of Subject Site.

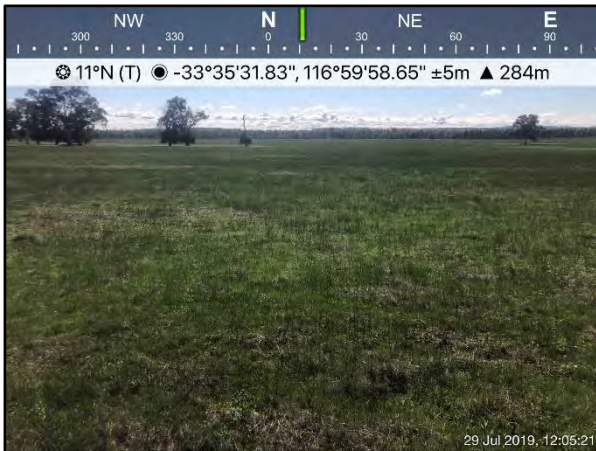
Photograph 3: View to the north across cleared Subject Site.

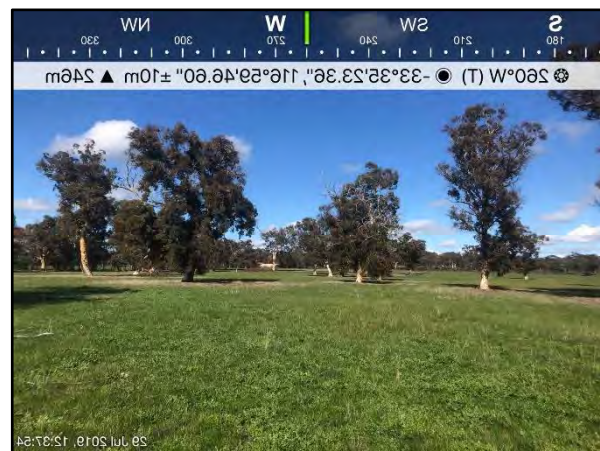
Photograph 4: View to the west in northern corner of the site.

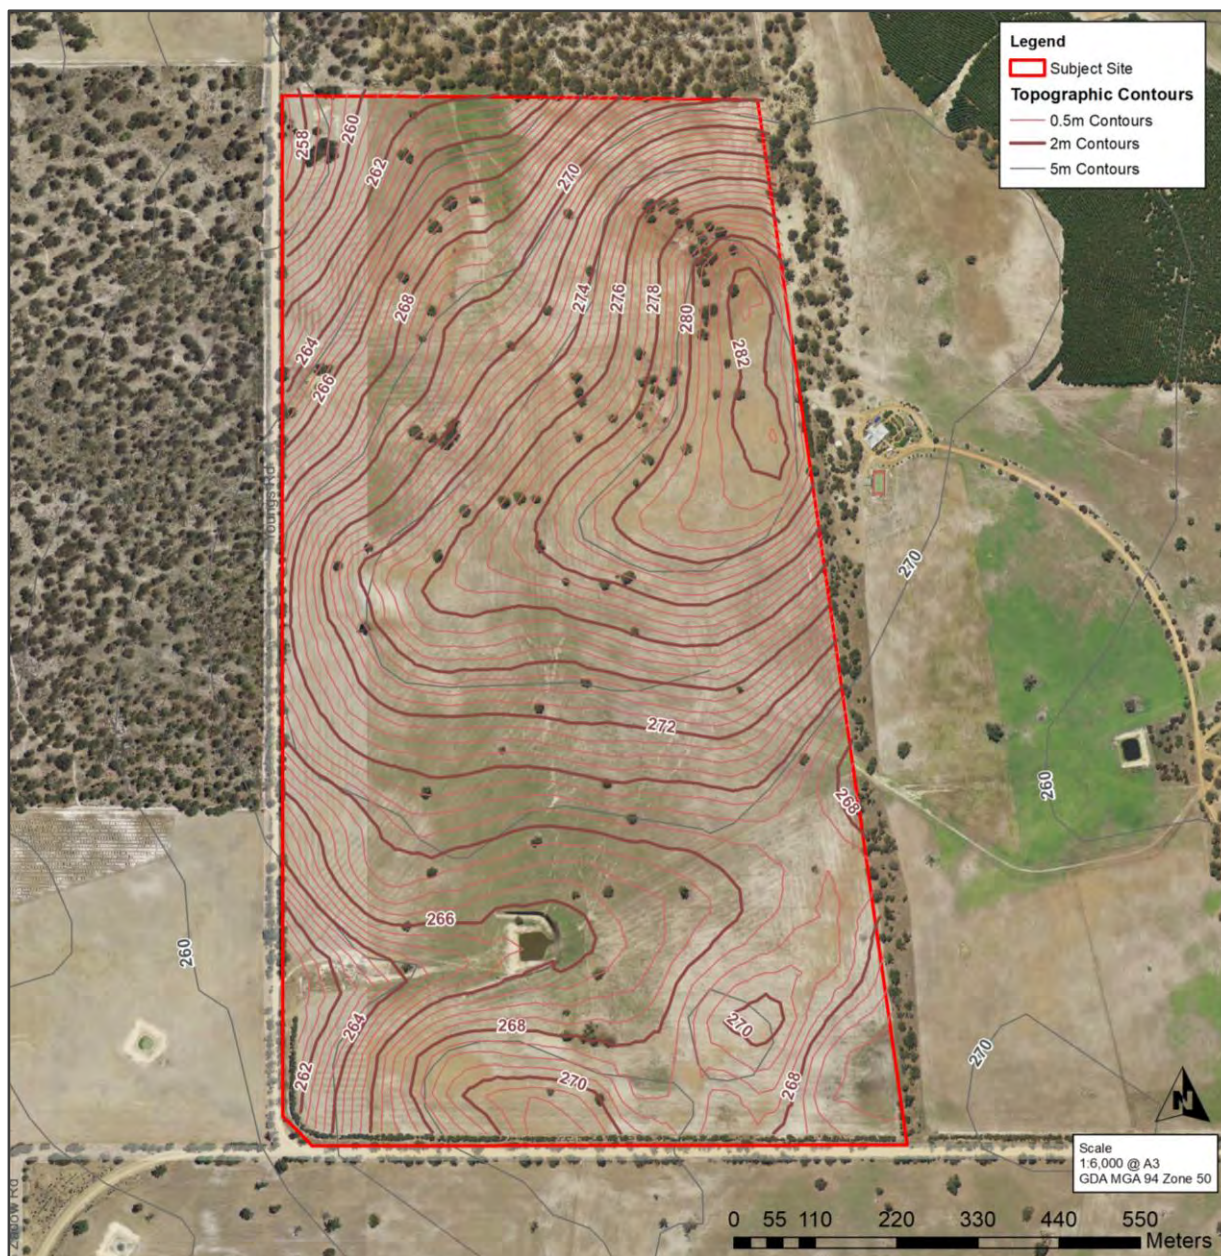
Figure 3: Topography

A feature survey for the Subject Site was conducted by Caldwell Land Surveys (2019), topographic contours from the survey are shown on Figure 3. The Subject Site topography is undulating with a high point of 282.5mAH in the north east of the site and a low point of 257.5mAH in the north western corner of the site. There is also a valley that runs from east to west in the southern portion of the site that has a low point of 261mAH. The Subject Site topography will be altered as part of the proposed development to ensure adequate drainage of the sheep pens and associated facilities.

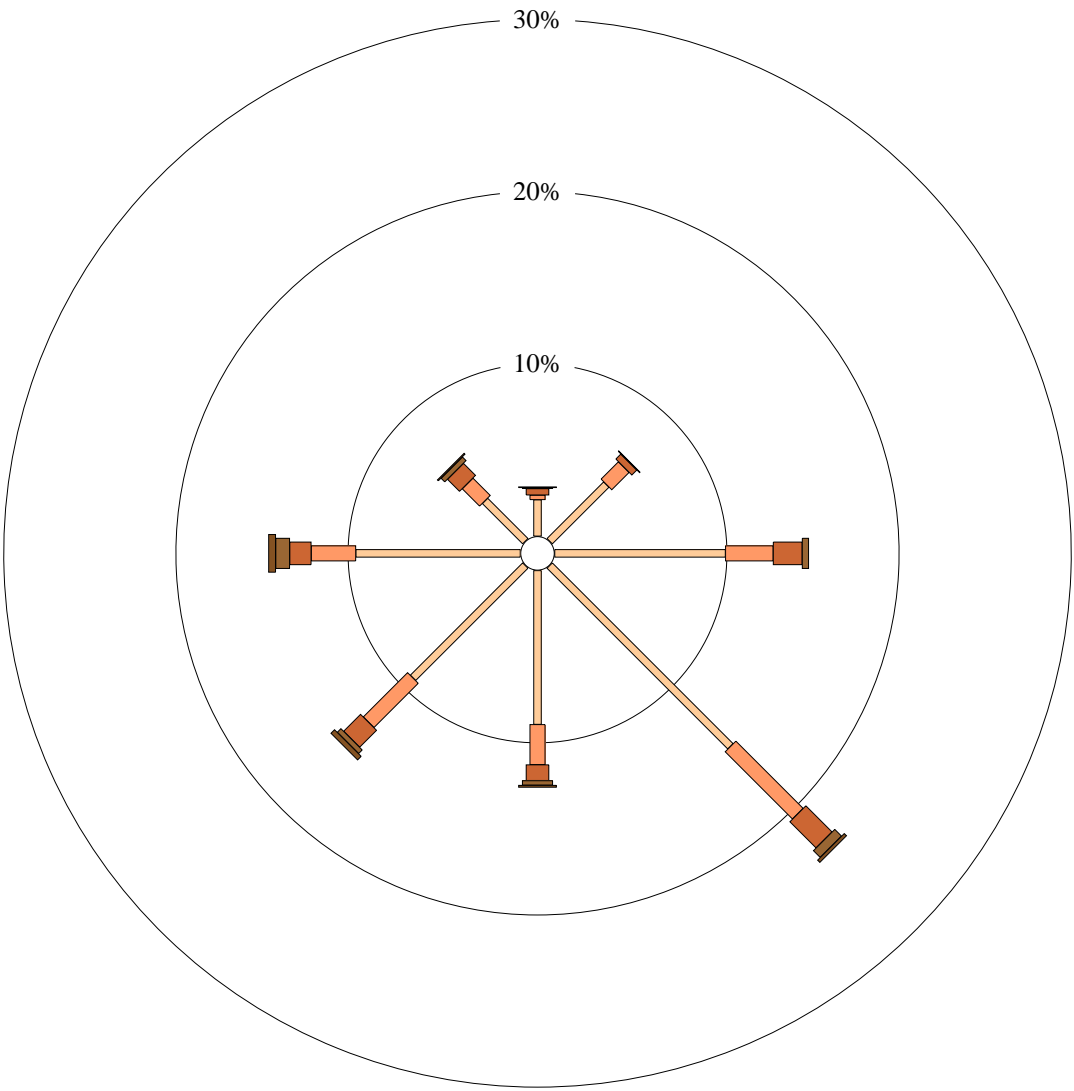
Rose of Wind direction versus Wind speed in km/h (03 Nov 1970 to 12 Aug 2019)

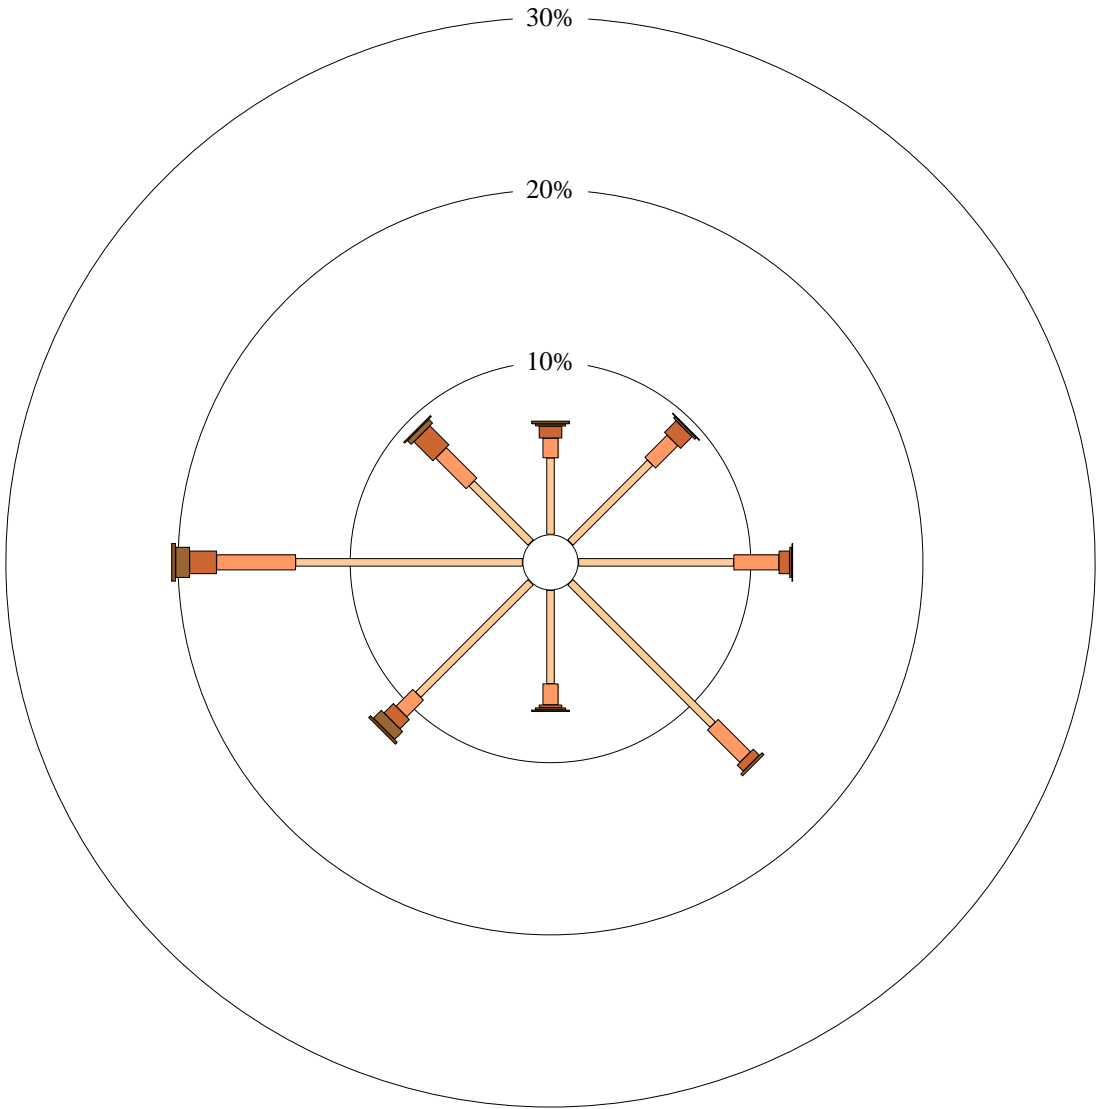
Rose of Wind direction versus Wind speed in km/h (03 Nov 1970 to 12 Aug 2019)

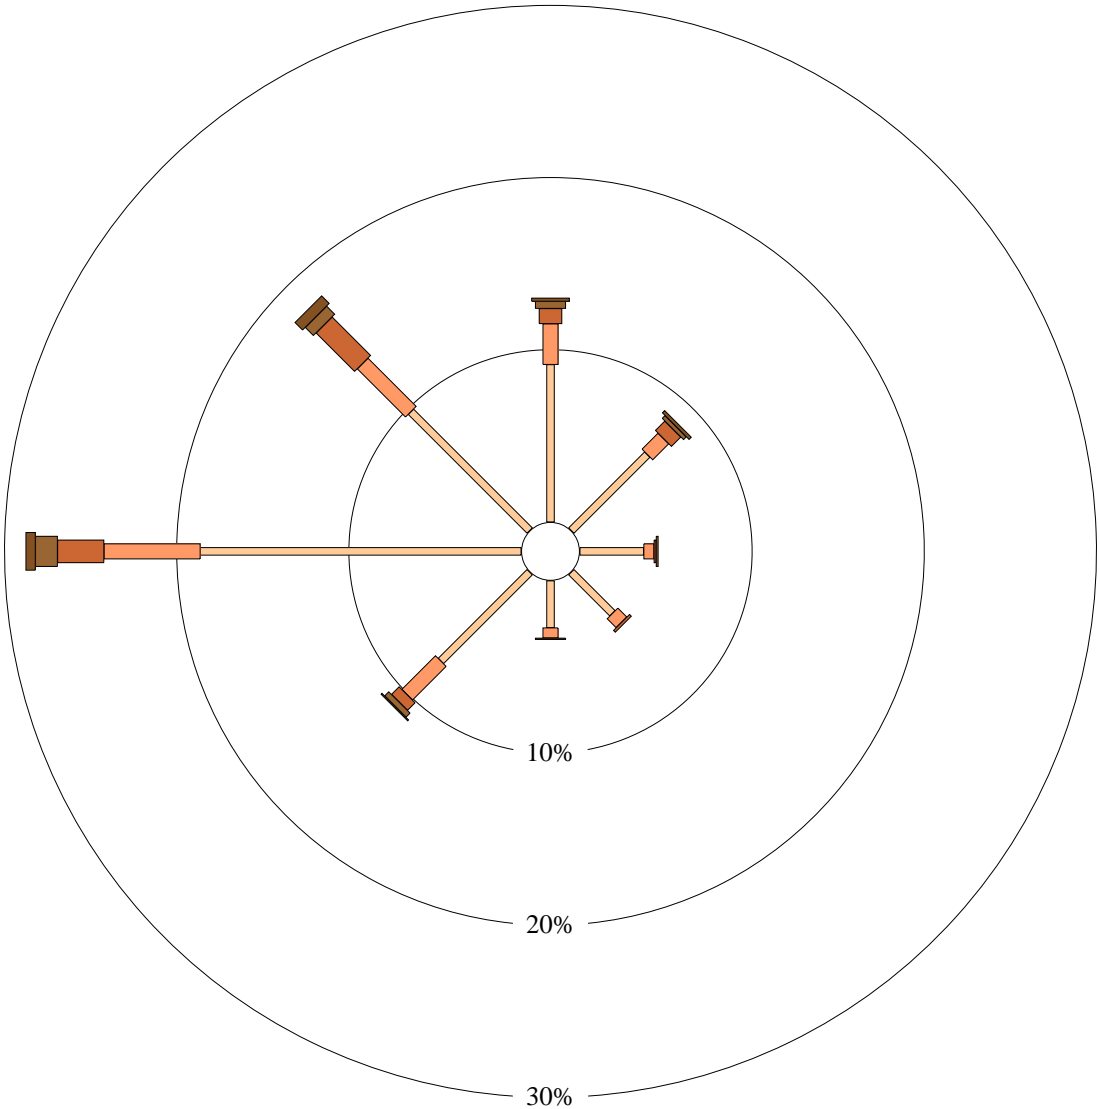
Rose of Wind direction versus Wind speed in km/h (03 Nov 1970 to 12 Aug 2019)

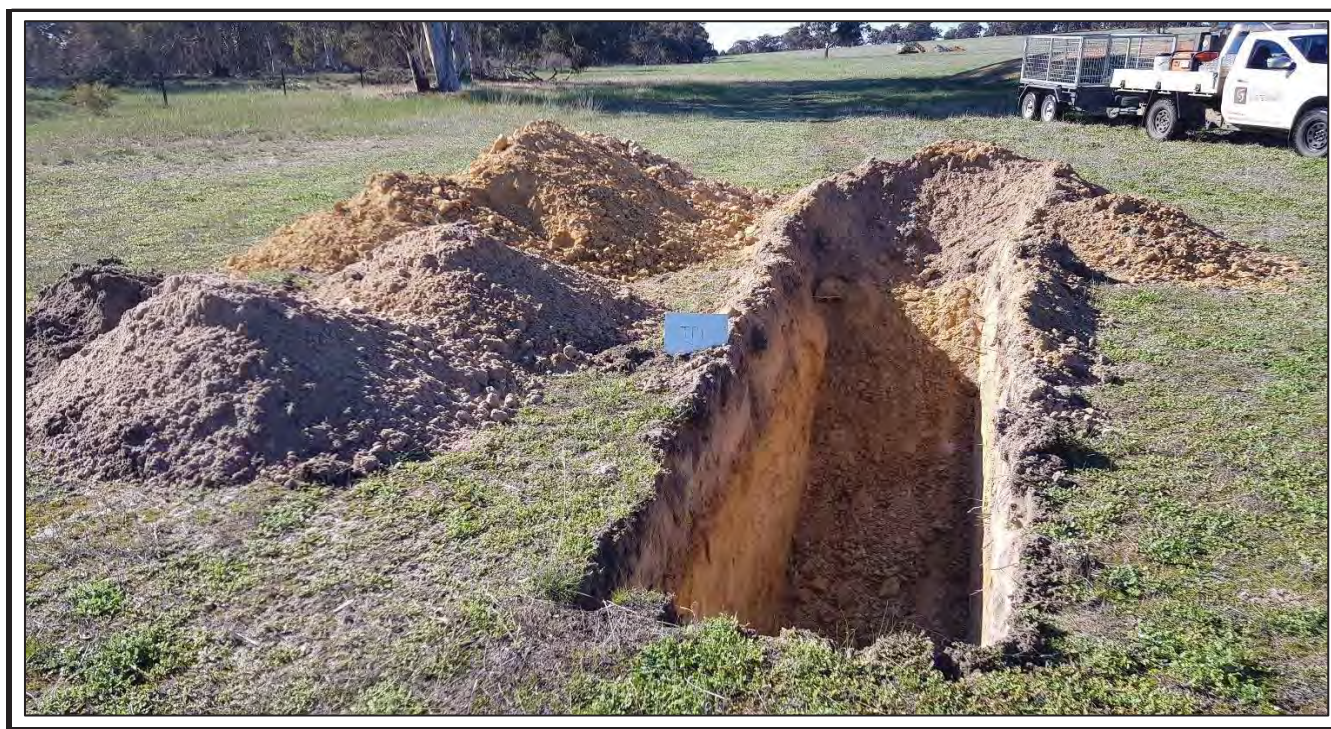
Test Pit No. 1 - Excavation

GREAT SOUTHERN GEOTECHNICS CONSTRUCTION MATERIALS TESTING		Job No 1919	Report 1919/1	Sheet 1 of 108				
Client: Fletchers International WA Project: Fletcher Proposed Feedlot Project Project No.: N/A Location: 670 Youngs Road, Beaufort River WA Test Pit No.: TP1 Sample No. 1919G1			Operator/Contractor: GSG Equipment type: Caterpillar 319DI 20 tonne Excavator Excavation Method : 900mm trenching bucket. Position: Refer to site plan					
Date Commenced: 29/07/2019		Logged By: M.Coffey		Excavation Dimensions: Depth 2.0 (m) Width 0.9 (m)				
Depth Below Surface (mm)	Layer Depth (mm)	Material Description <small>SOIL TYPE, Plasticity, Colour, Particle characteristics, Secondary and other minor components</small>	Moist. Condition	Consistency / Strength	Cementation	Water Table	Classification Symbol	Sample/Test
0 - 150	150	(Topsoil) SAND with silt: Grey, fine to medium. Roots & root fibres.	M	MD		No water table encountered.

150 - 400	250	SAND: Light grey, fine to coarse.	M	L-MD				
400 - 600	200	Sandy GRAVEL: Brown, fine to medium, sub rounded to sub angular. <small>Fine to medium grained sand.</small>	M	MD				
600 - 2000	1400	Sandy CLAY: Low to medium plasticity, light brown mottled orange.	M	St				
Comments			Pit Terminated at: (mm) below ground level ✓ or ✕					
			Target Depth ✓ 2000					
			Cave In					
			Refusal					
			Near Refusal					
			Flooding					
			Lack of Reach					
Materials Consistency/Strength		Rock	Cementation		▼ Water Water first Encountered			
Cohesive	Non-Cohesive				Moisture D - Dry M - Moist W - Wet			
VS - Very Soft S - Soft F - Firm St - Stiff VSt - Very Stiff H - Hard	VL - Very Loose L - Loose MD - Medium Dense D - Dense VD - Very Dense CO - Compact	EL - Extremely Low VL - Very Low L - Low M - Medium H - High VH - Very High EH - Extremely High	IN - Indurated PC - Poorly Cemented MC - moderately Cemented WC - Well Cemented		General N/A - Not Applicable N/D - Not Determined

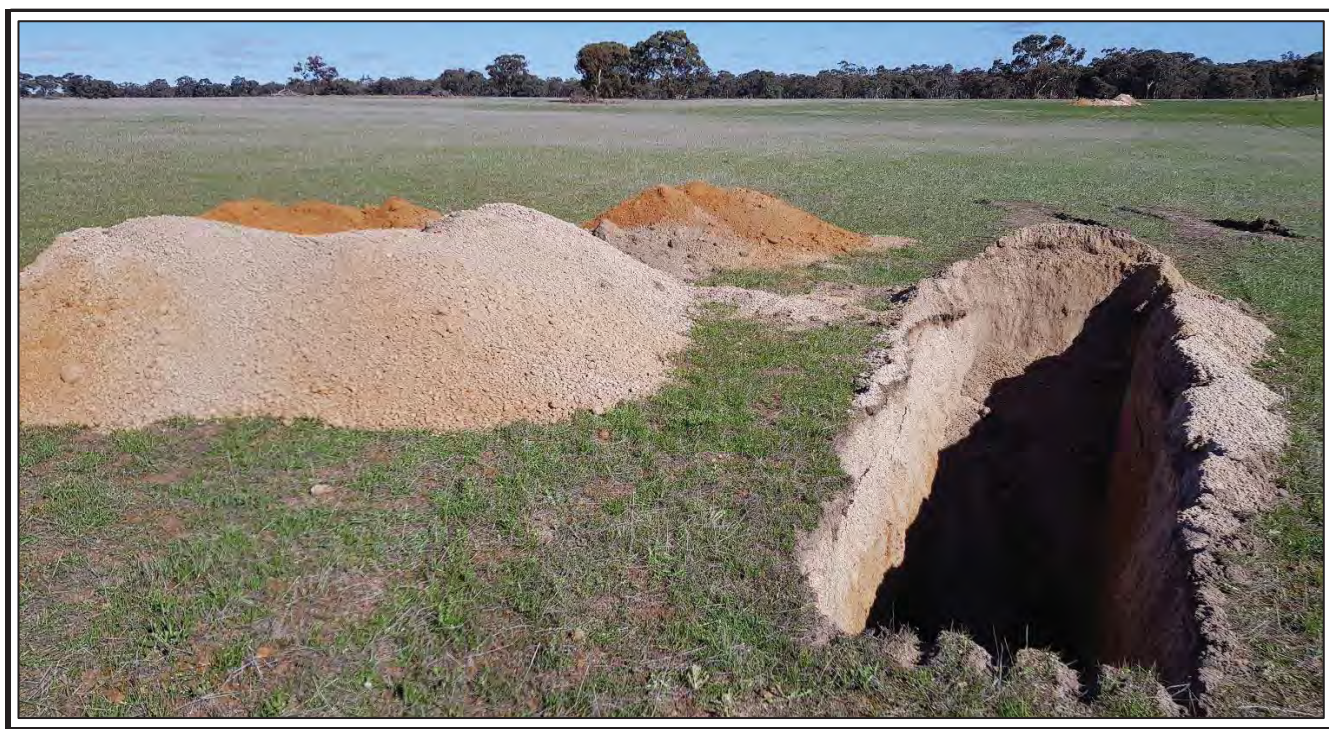
Test Pit No. 3 - Excavation

GREAT SOUTHERN GEOTECHNICS CONSTRUCTION MATERIALS TESTING		Job No 1919	Report 1919/1	Sheet 5 of 108				
Client: Fletchers International WA Project: Fletcher Proposed Feedlot Project Project No.: N/A Location: 670 Youngs Road, Beaufort River WA Test Pit No.: TP3 Sample No. 1919G3		Operator/Contractor: GSG Equipment type: Caterpillar 319DI 20 tonne Excavator Excavation Method : 900mm trenching bucket. Position: Refer to site plan						
Date Commenced: 29/07/2019		Logged By: M.Coffey		Excavation Dimensions: Depth 2.3 (m) Width 0.9 (m)				
Depth Below Surface (mm)	Layer Depth (mm)	Material Description <small>SOIL TYPE, Plasticity, Colour, Particle characteristics, Secondary and other minor components</small>	Moist. Condition	Consistency / Strength	Cementation	Water Table	Classification Symbol	Sample/Test
0 - 100	100	(Topsoil) SAND with silt: Brown/Grey, fine to medium. Roots & root fibres.	M	L-MD		No water table encountered.

100 - 600	500	Sandy GRAVEL: Light brown, fine to medium, sub rounded. Fine to medium grained sand.	M	MD				
600 - 1500	900	Sandy GRAVEL: Brown, fine to coarse, sub rounded. Fine to medium grained sand. Contains approx. 5-10% boulders up to 300mm diameter.	M	MD				
1500 - 2300	800	Gravelly CLAY: Low plasticity, red/orange. Fine to medium, sub rounded gravel.	M-W	F-St				
Comments			Pit Terminated at: (mm) below ground level ✓ or ✕					
			Target Depth ✓ 2300					
			Cave In					
			Refusal					
			Near Refusal					
			Flooding					
			Lack of Reach					
Materials Consistency/Strength		Rock	Cementation		▼ Water Water first Encountered			
Cohesive	Non-Cohesive				Moisture D - Dry M - Moist W - Wet			
VS - Very Soft S - Soft F - Firm St - Stiff VSt - Very Stiff H - Hard	VL - Very Loose L - Loose MD - Medium Dense D - Dense VD - Very Dense CO - Compact	EL - Extremely Low VL - Very Low L - Low M - Medium H - High VH - Very High EH - Extremely High	IN - Indurated PC - Poorly Cemented MC - moderately Cemented WC - Well Cemented		General N/A - Not Applicable N/D - Not Determined

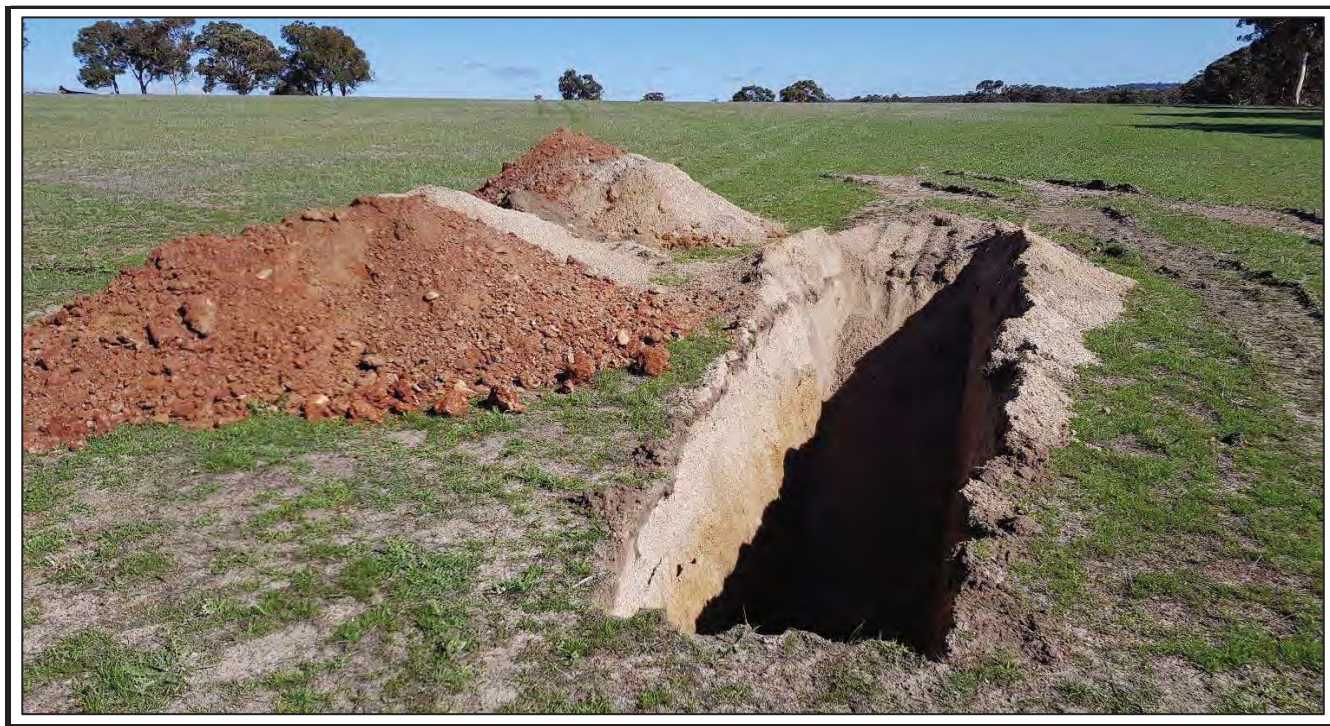
Test Pit No. 4 - Excavation

100 - 1200	1100	Sandy GRAVEL: Light brown to brown, fine, sub rounded to sub angular. Fine to medium grained sand.	M	MD				
1200 - 2000	800	Sandy CLAY: Low to medium plasticity, red mottled grey /orange.	M	St				
Comments			Pit Terminated at: (mm) below ground level ✓ or ✕					
			Target Depth ✓ 2000					
			Cave In					
			Refusal					
			Near Refusal					
			Flooding					
			Lack of Reach					
Materials Consistency/Strength		Rock	Cementation		▼ Water Water first Encountered			
Cohesive	Non-Cohesive				Moisture D - Dry M - Moist W - Wet			
VS - Very Soft S - Soft F - Firm St - Stiff VSt - Very Stiff H - Hard	VL - Very Loose L - Loose MD - Medium Dense D - Dense VD - Very Dense CO - Compact	EL - Extremely Low VL - Very Low L - Low M - Medium H - High VH - Very High EH - Extremely High	IN - Indurated PC - Poorly Cemented MC - moderately Cemented WC - Well Cemented		General N/A - Not Applicable N/D - Not Determined

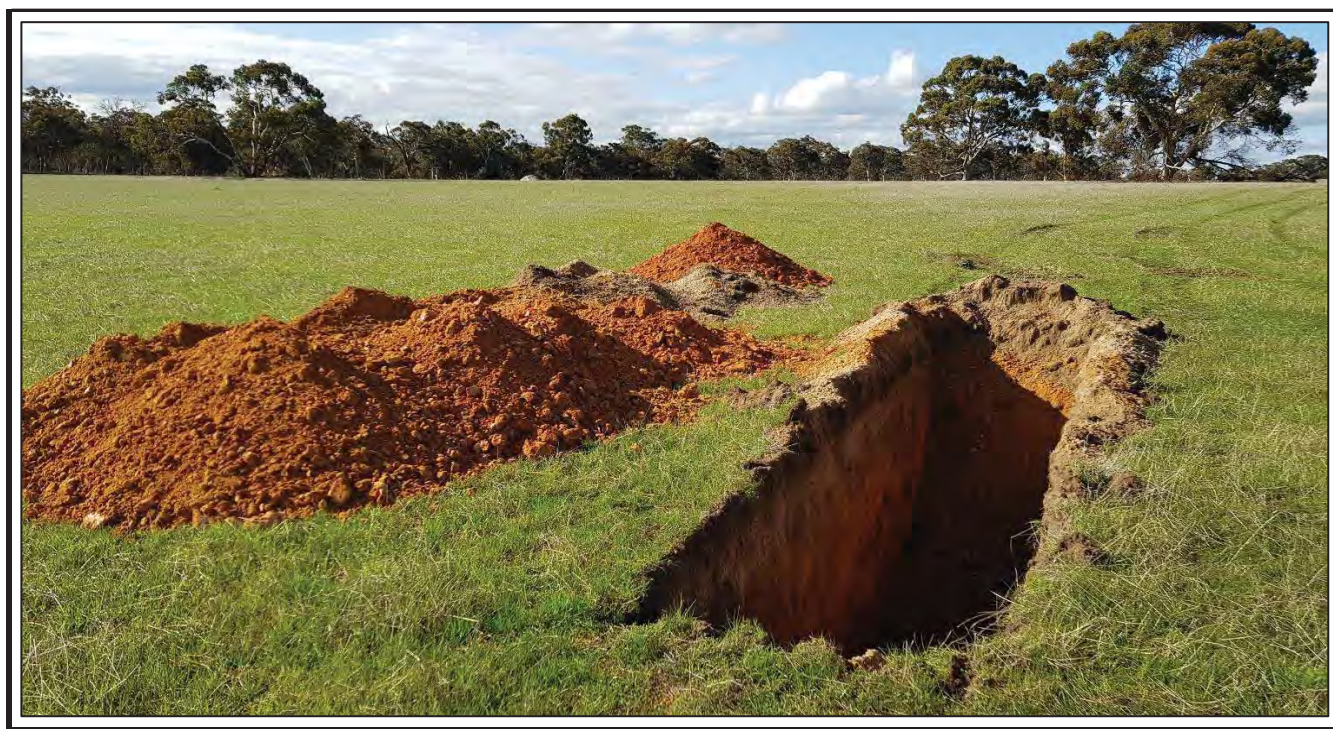
Test Pit No. 5 - Excavation

GREAT SOUTHERN GEOTECHNICS CONSTRUCTION MATERIALS TESTING		Job No 1919	Report 1919/1	Sheet 9 of 108				
Client: Fletchers International WA Project: Fletcher Proposed Feedlot Project Project No.: N/A Location: 670 Youngs Road, Beaufort River WA Test Pit No.: TP5 Sample No. 1919G5			Operator/Contractor: GSG Equipment type: Caterpillar 319DI 20 tonne Excavator Excavation Method : 900mm trenching bucket. Position: Refer to site plan					
Date Commenced: 29/07/2019		Logged By: M.Coffey		Excavation Dimensions: Depth 2.0 (m) Width 0.9 (m)				
Depth Below Surface (mm)	Layer Depth (mm)	Material Description <small>SOIL TYPE, Plasticity, Colour, Particle characteristics, Secondary and other minor components</small>	Moist. Condition	Consistency / Strength	Cementation	Water Table	Classification Symbol	Sample/Test
0 - 150	150	(Topsoil) SAND with silt: Grey, fine to medium. Roots & root fibres.	M	L-MD		No water table encountered.

150 - 450	300	Sandy GRAVEL: Light brown, fine to medium, sub rounded to rounded. Fine to medium grained sand.	M	MD				
450 - 850	400	Gravelly CLAY: Low to medium plasticity, light brown/orange. Fine to medium, sub rounded to sub angular gravel. Fine to medium grained sand.	M	F-St				
850 - 2000	1150	Sandy CLAY: Low to medium plasticity, brown/red mottled orange.	M	St				
Comments			Pit Terminated at: (mm) below ground level ✓ or ✕					
			Target Depth ✓ 2000					
			Cave In					
			Refusal					
			Near Refusal					
			Flooding					
			Lack of Reach					
Materials Consistency/Strength		Rock	Cementation		▼ Water Water first Encountered			
Cohesive	Non-Cohesive				Moisture D - Dry M - Moist W - Wet			
VS - Very Soft S - Soft F - Firm St - Stiff VSt - Very Stiff H - Hard	VL - Very Loose L - Loose MD - Medium Dense D - Dense VD - Very Dense CO - Compact	EL - Extremely Low VL - Very Low L - Low M - Medium H - High VH - Very High EH - Extremely High	IN - Indurated PC - Poorly Cemented MC - moderately Cemented WC - Well Cemented		General N/A - Not Applicable N/D - Not Determined

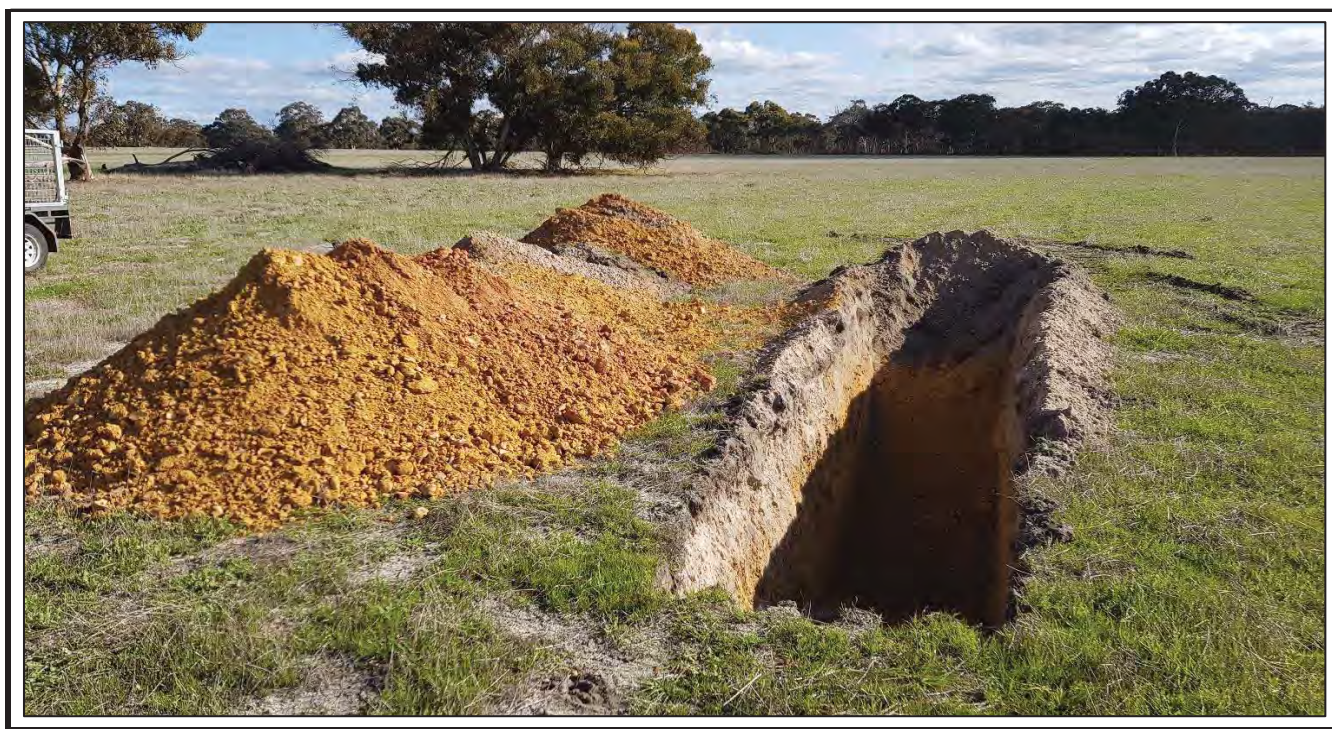
Test Pit No. 9 - Excavation

100 - 550	450	Sandy GRAVEL: Light brown/grey, fine to medium, sub rounded to sub angular. Fine to medium grained sand.	D	MD				
550 - 850	300	Sandy GRAVEL with clay: Low plasticity, light brown/orange. Fine to medium, sub rounded gravel. Fine to medium grained sand.	M	MD				
850 - 2000	1150	Sandy CLAY: Low to medium plasticity, light brown/orange to light brown/orange mottled red/grey.	M	F-St				
Comments			Pit Terminated at: (mm) below ground level ✓ or ✕					
			Target Depth ✓ 2000					
			Cave In					
			Refusal					
			Near Refusal					
			Flooding					
			Lack of Reach					
Materials Consistency/Strength		Rock	Cementation		▼ Water Water first Encountered			
Cohesive	Non-Cohesive				Moisture D - Dry M - Moist W - Wet			
VS - Very Soft S - Soft F - Firm St - Stiff VSt - Very Stiff H - Hard	VL - Very Loose L - Loose MD - Medium Dense D - Dense VD - Very Dense CO - Compact	EL - Extremely Low VL - Very Low L - Low M - Medium H - High VH - Very High EH - Extremely High	IN - Indurated PC - Poorly Cemented MC - moderately Cemented WC - Well Cemented		General N/A - Not Applicable N/D - Not Determined

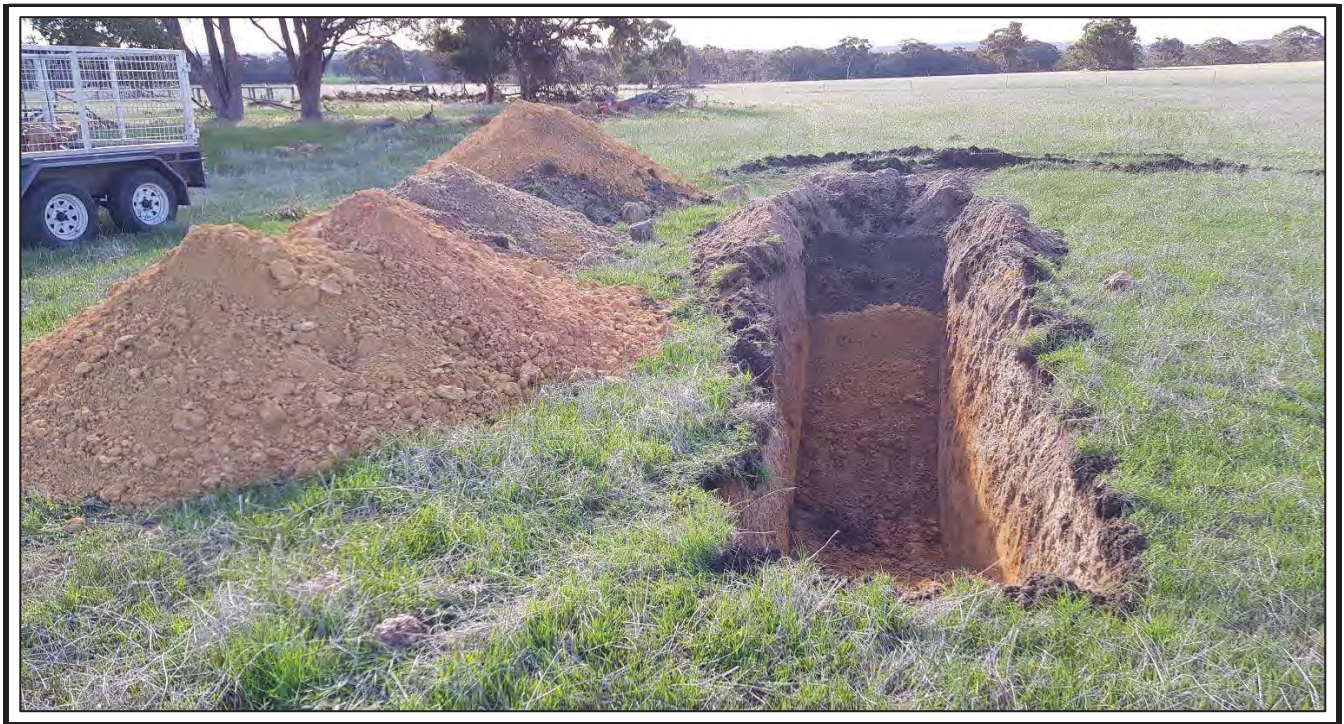
Test Pit No. 10 - Excavation

100 - 650	550	Sandy GRAVEL: Light brown/grey, fine to medium, sub rounded to sub angular. Fine to medium grained sand. Contains approx. 5-10% boulders up to 400mm diameter.		M	MD				
650 - 950	300	Sandy GRAVEL with clay: Low plasticity, light brown/orange. Fine to medium, sub rounded gravel. Fine to medium grained sand.		M	MD				
950 - 2000	1050	Sandy CLAY: Low to medium plasticity, light brown/orange to light brown/orange mottled red.		M	F-St				
Comments				Pit Terminated at: (mm) below ground level					
				✓ or ✗					
				Target Depth					
				Cave In					
				Refusal					
				Near Refusal					
				Flooding					
				Lack of Reach					
Materials Consistency/Strength		Rock	Cementation	▼ Water Water first Encountered Moisture D - Dry M - Moist W - Wet General N/A - Not Applicable N/D - Not Determined					
Cohesive	Non-Cohesive								
VS - Very Soft S - Soft F - Firm St - Stiff VSt - Very Stiff H - Hard	VL - Very Loose L - Loose MD - Medium Dense D - Dense VD - Very Dense CO - Compact	EL - Extremely Low VL - Very Low L - Low M - Medium H - High VH - Very High EH - Extremely High	IN - Indurated PC - Poorly Cemented MC - moderately Cemented WC - Well Cemented

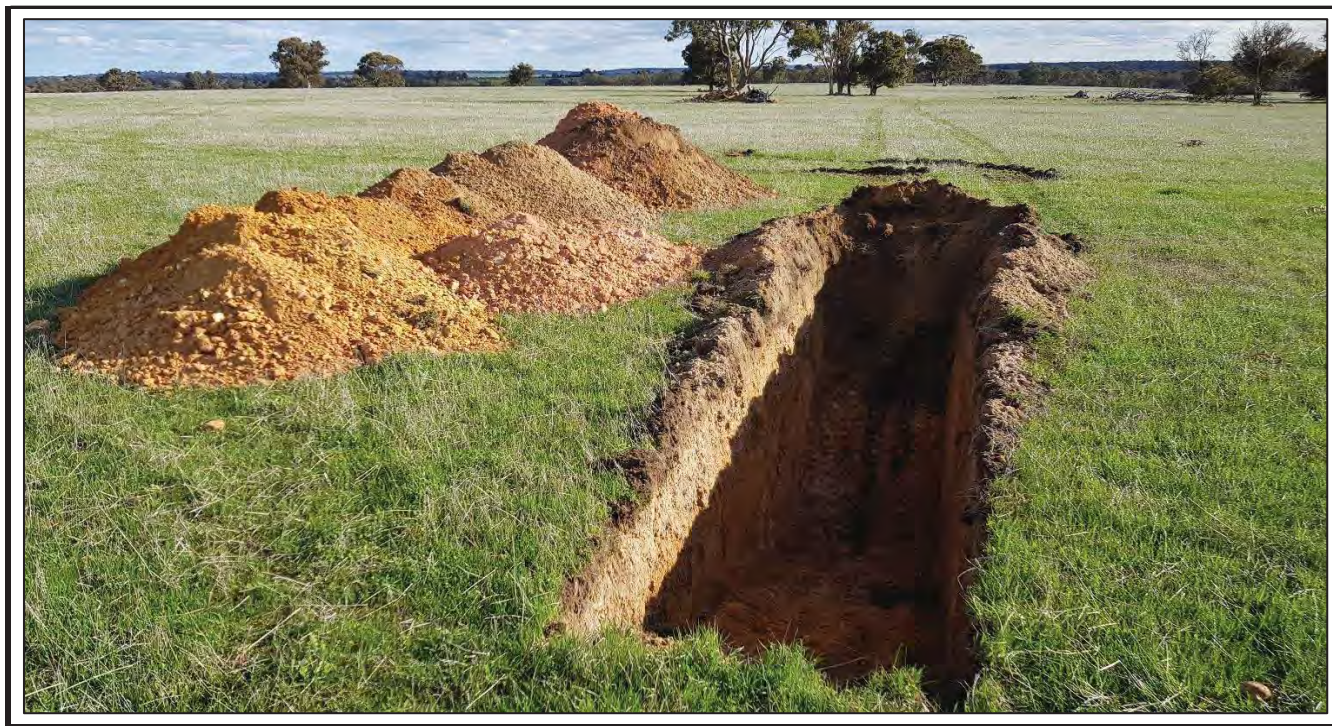
Test Pit No. 11 - Excavation

GREAT SOUTHERN GEOTECHNICS CONSTRUCTION MATERIALS TESTING		Job No	1919	Report	1919/1	Sheet	21	of	108
Client: Fletchers International WA Project: Fletcher Proposed Feedlot Project Project No.: N/A Location: 670 Youngs Road, Beaufort River WA Test Pit No.: TP11 Sample No. 1919G11				Operator/Contractor: GSG Equipment type: Caterpillar 319DI 20 tonne Excavator Excavation Method : 900mm trenching bucket. Position: Refer to site plan					
Date Commenced:		29/07/2019		Logged By:		M.Coffey		Excavation Dimensions:	
				Depth		2.0 (m)		Width 0.9 (m)	
Depth Below Surface (mm)	Layer Depth (mm)	Material Description		Moist. Condition	Consistency / Strength	Cementation	Water Table	Classification Symbol	Sample/Test
		SOIL TYPE, Plasticity, Colour, Particle characteristics, Secondary and other minor components							
0 - 100	100	(Topsoil) SAND with silt: Grey, fine to medium. Roots & root fibres.		M	L-MD		No water table encountered.

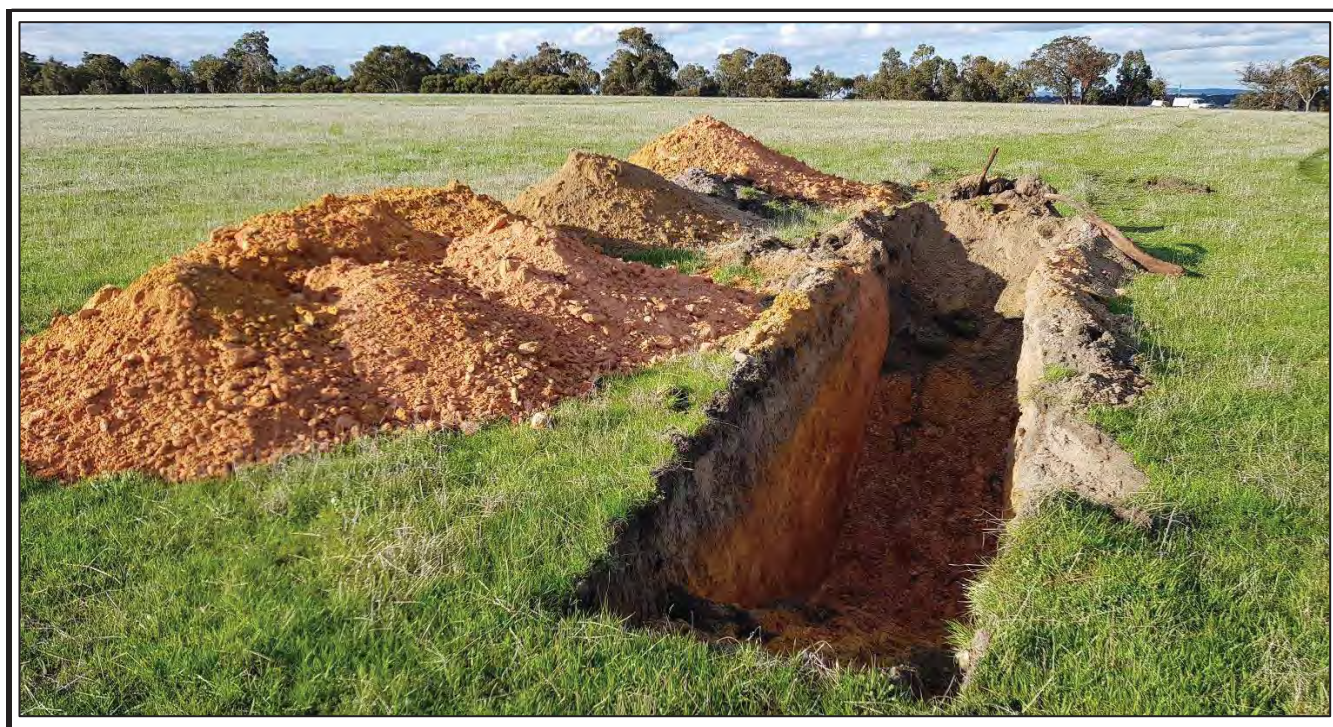
Test Pit No. 14 - Excavation

GREAT SOUTHERN GEOTECHNICS CONSTRUCTION MATERIALS TESTING		Job No	1919	Report	1919/1	Sheet	27	of	108
Client: Fletchers International WA Project: Fletcher Proposed Feedlot Project Project No.: N/A Location: 670 Youngs Road, Beaufort River WA Test Pit No.: TP14 Sample No. 1919G14				Operator/Contractor: GSG Equipment type: Caterpillar 319DI 20 tonne Excavator Excavation Method : 900mm trenching bucket. Position: Refer to site plan					
Date Commenced:		29/07/2019		Logged By:		M.Coffey		Excavation Dimensions:	
				Depth		2.0 (m)		Width 0.9 (m)	
Depth Below Surface (mm)	Layer Depth (mm)	Material Description		Moist. Condition	Consistency / Strength	Cementation	Water Table	Classification Symbol	Sample/Test
		SOIL TYPE, Plasticity, Colour, Particle characteristics, Secondary and other minor components							
0 - 200	200	(Topsoil) SAND with silt: Grey, fine to medium. Roots & root fibres.		M	L-MD		No water table encountered.

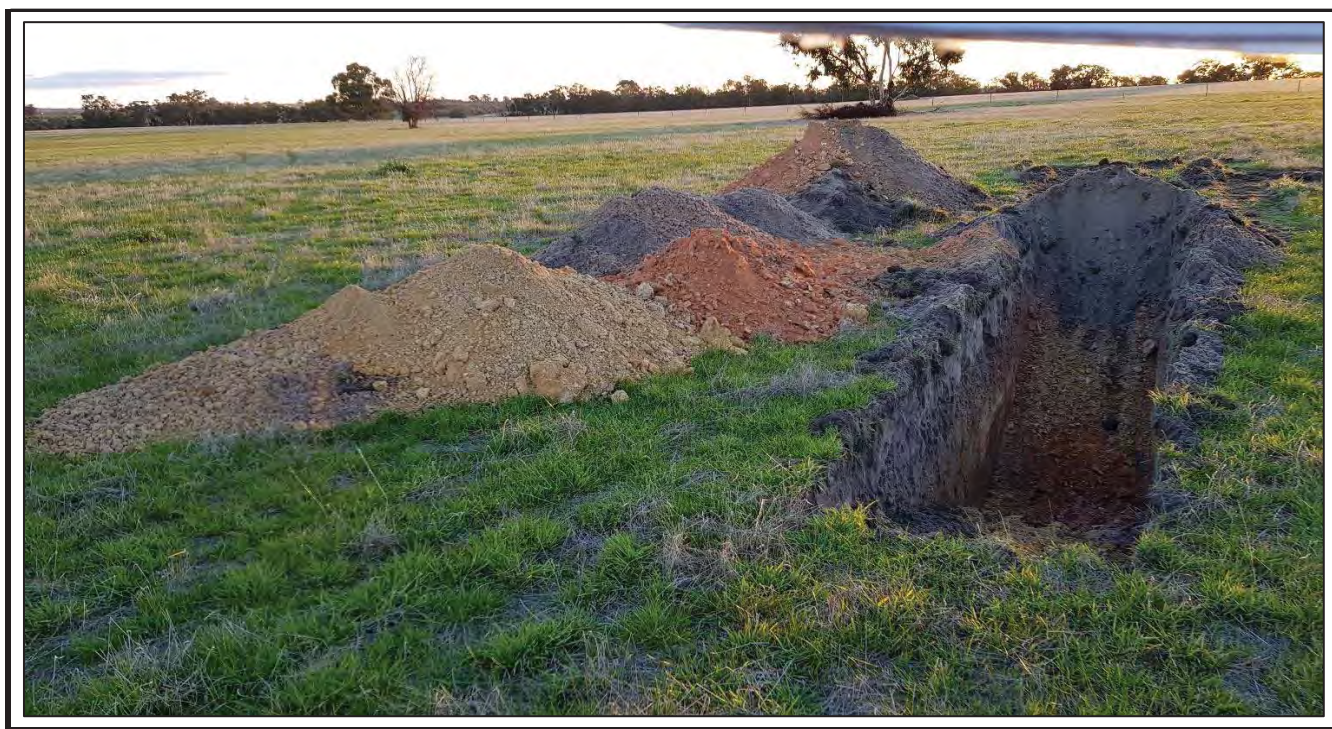
Test Pit No. 18 - Excavation

GREAT SOUTHERN GEOTECHNICS CONSTRUCTION MATERIALS TESTING		Job No	1919	Report	1919/1	Sheet	35	of	108
Client: Fletchers International WA Project: Fletcher Proposed Feedlot Project Project No.: N/A Location: 670 Youngs Road, Beaufort River WA Test Pit No.: TP18 Sample No. 1919G18				Operator/Contractor: GSG Equipment type: Caterpillar 319DI 20 tonne Excavator Excavation Method : 900mm trenching bucket. Position: Refer to site plan					
Date Commenced:		29/07/2019		Logged By:		M.Coffey		Excavation Dimensions:	
				Depth		2.0 (m)		Width 0.9 (m)	
Depth Below Surface (mm)	Layer Depth (mm)	Material Description		Moist. Condition	Consistency / Strength	Cementation	Water Table	Classification Symbol	Sample/Test
0 - 100	100	(Topsoil) SAND with silt: Grey, fine to medium. Roots & root fibres.		M	L-MD		No water table encountered.		
100 - 450	350	SAND: Light grey, fine to medium.		M	L-MD				
450 - 700	250	Sandy GRAVEL: Light brown/grey, fine to coarse, sub rounded to sub angular. Fine to medium grained sand.		M	MD

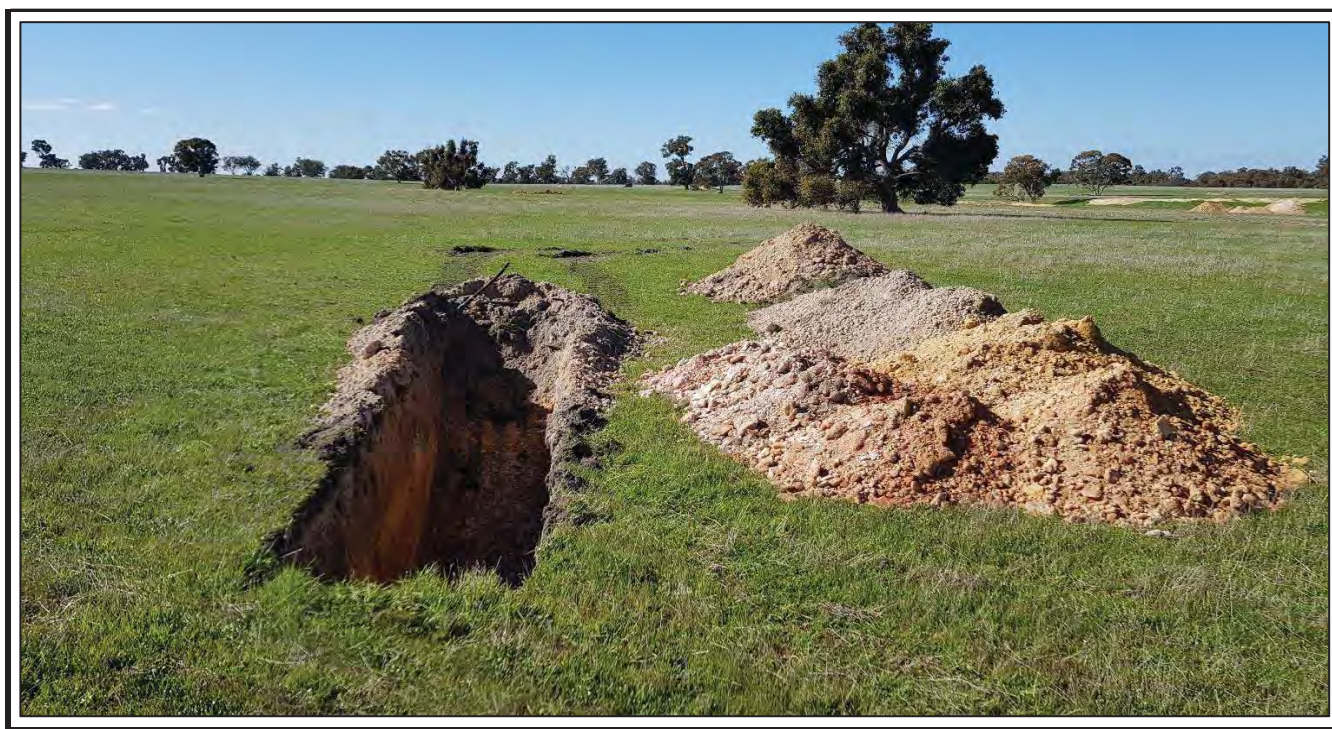
Test Pit No. 20 - Excavation

GREAT SOUTHERN GEOTECHNICS CONSTRUCTION MATERIALS TESTING		Job No	1919	Report	1919/1	Sheet	39	of	108
Client: Fletchers International WA Project: Fletcher Proposed Feedlot Project Project No.: N/A Location: 670 Youngs Road, Beaufort River WA Test Pit No.: TP20 Sample No. 1919G20				Operator/Contractor: GSG Equipment type: Caterpillar 319DI 20 tonne Excavator Excavation Method : 900mm trenching bucket. Position: Refer to site plan					
Date Commenced:		30/07/2019		Logged By:		M.Coffey		Excavation Dimensions:	
				Depth		2.0 (m)		Width 0.9 (m)	
Depth Below Surface (mm)	Layer Depth (mm)	Material Description		Moist. Condition	Consistency / Strength	Cementation	Water Table	Classification Symbol	Sample/Test
0 - 150	150	(Topsoil) SAND with silt: Grey, fine to medium. Roots & root fibres.		M	L-MD		No water table encountered.		
150 - 250	100	SAND: Light grey, fine to medium.		M	L-MD				
250 - 550	300	Sandy GRAVEL: Light brown/grey, fine to coarse, sub rounded to sub angular. Fine to medium grained sand.		M	MD

550 - 700	150	Sandy GRAVEL with clay: Low plasticity, brown/orange. Fine to medium, sub rounded to sub angular gravel. Fine to medium grained sand.		M	MD				
700 - 1100	400	Sandy CLAY: Low to medium plasticity, light brown/grey mottled orange. Fine to medium grained sand.		M	F-St				
1100 - 2000	900	Sandy CLAY: Low to medium plasticity, light brown/grey mottled orange/red/white. Fine to medium grained sand.		M	St				
Comments				Pit Terminated at: (mm) below ground level ✓ or ✕					
				Target Depth <input checked="" type="checkbox"/> 2000 Cave In <input type="checkbox"/> Refusal <input type="checkbox"/> Near Refusal <input type="checkbox"/> Flooding <input type="checkbox"/> Lack of Reach <input type="checkbox"/>					
Materials Consistency/Strength		Rock	Cementation	▼ Water Water first Encountered Moisture D - Dry M - Moist W - Wet General N/A - Not Applicable N/D - Not Determined					
Cohesive VS - Very Soft S - Soft F - Firm St - Stiff VSt - Very Stiff H - Hard	Non-Cohesive VL - Very Loose L - Loose MD - Medium Dense D - Dense VD - Very Dense CO - Compact	EL - Extremely Low VL - Very Low L - Low M - Medium H - High VH - Very High EH - Extremely High	IN - Indurated PC - Poorly Cemented MC - moderately Cemented WC - Well Cemented

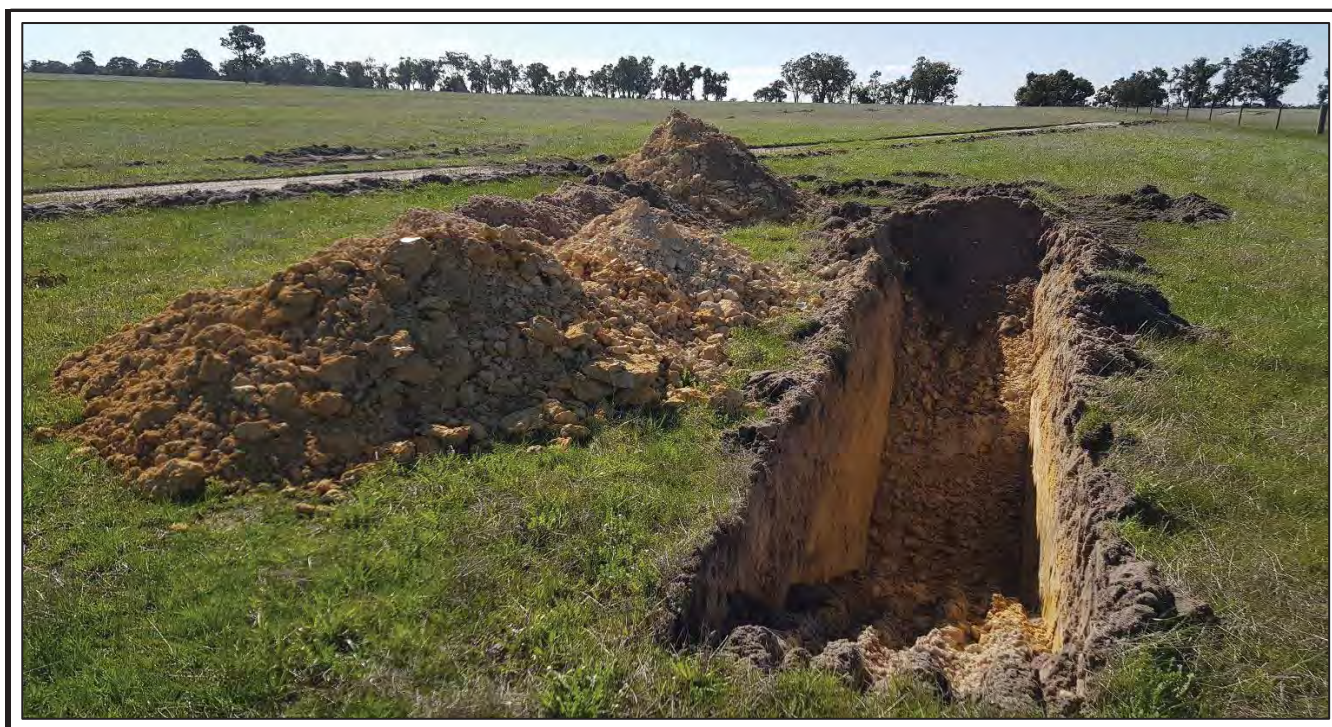
Test Pit No. 22 - Excavation

600 - 750	150	Sandy GRAVEL with clay: Low plasticity, brown/orange. Fine to medium, sub rounded to sub angular gravel. Fine to medium grained sand.	M	MD				
750 - 1600	850	Sandy CLAY: Low to medium plasticity, light brown/grey mottled orange. Fine to medium grained sand.	M	F				
1600 - 2000	400	Silty CLAY: Low to medium plasticity, light brown/white.	M	F-St				
Comments			Pit Terminated at: (mm) below ground level ✓ or ✕					
			Target Depth		✓	2000		
			Cave In					
			Refusal					
			Near Refusal					
			Flooding					
			Lack of Reach					
Materials Consistency/Strength		Rock	Cementation	▼ Water				
Cohesive	Non-Cohesive			Water first Encountered				
VS - Very Soft S - Soft F - Firm St - Stiff VSt - Very Stiff H - Hard	VL - Very Loose L - Loose MD - Medium Dense D - Dense VD - Very Dense CO - Compact	EL - Extremely Low VL - Very Low L - Low M - Medium H - High VH - Very High EH - Extremely High	IN - Indurated PC - Poorly Cemented MC - moderately Cemented WC - Well Cemented	Moisture

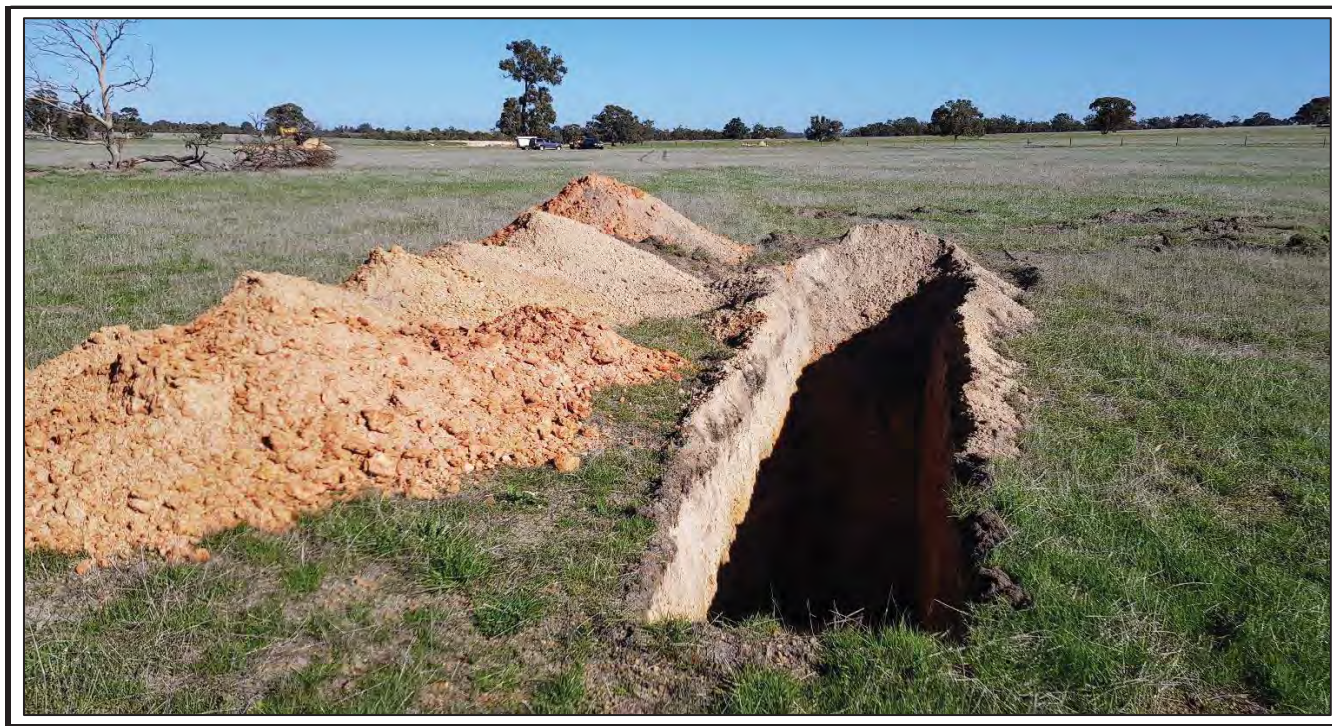
Test Pit No. 23 - Excavation

550 - 800	250	Sandy GRAVEL with clay: Low plasticity, brown/orange. Fine to medium, sub rounded to sub angular gravel. Fine to medium grained sand.	M	MD				
800 - 2000	1200	Sandy CLAY: Low to medium plasticity, light brown/grey mottled red/orange. Fine to medium grained sand.	M	F-St				
Comments			Pit Terminated at: (mm) below ground level ✓ or ✕					
			Target Depth					
			Cave In					
			Refusal					
			Near Refusal					
			Flooding					
			Lack of Reach					
Materials Consistency/Strength		Rock	Cementation		▼ Water			
Cohesive	Non-Cohesive				Water first Encountered			
VS - Very Soft S - Soft F - Firm St - Stiff VSt - Very Stiff H - Hard	VL - Very Loose L - Loose MD - Medium Dense D - Dense VD - Very Dense CO - Compact	EL - Extremely Low VL - Very Low L - Low M - Medium H - High VH - Very High EH - Extremely High	IN - Indurated PC - Poorly Cemented MC - moderately Cemented WC - Well Cemented		Moisture
