SHIRE OF WOODANILLING

SPECIAL MEETING OF COUNCIL Agenda 2 June 2020

A Special Council Meeting has been called by resolution of Council for 4pm on 2 June 2020 at the Recreation Pavilion on Yairabin Street Woodanilling. The purpose of the meeting is to consider the Feedlot Development Application for Lots 1 & 4 Youngs Road Beaufort River.

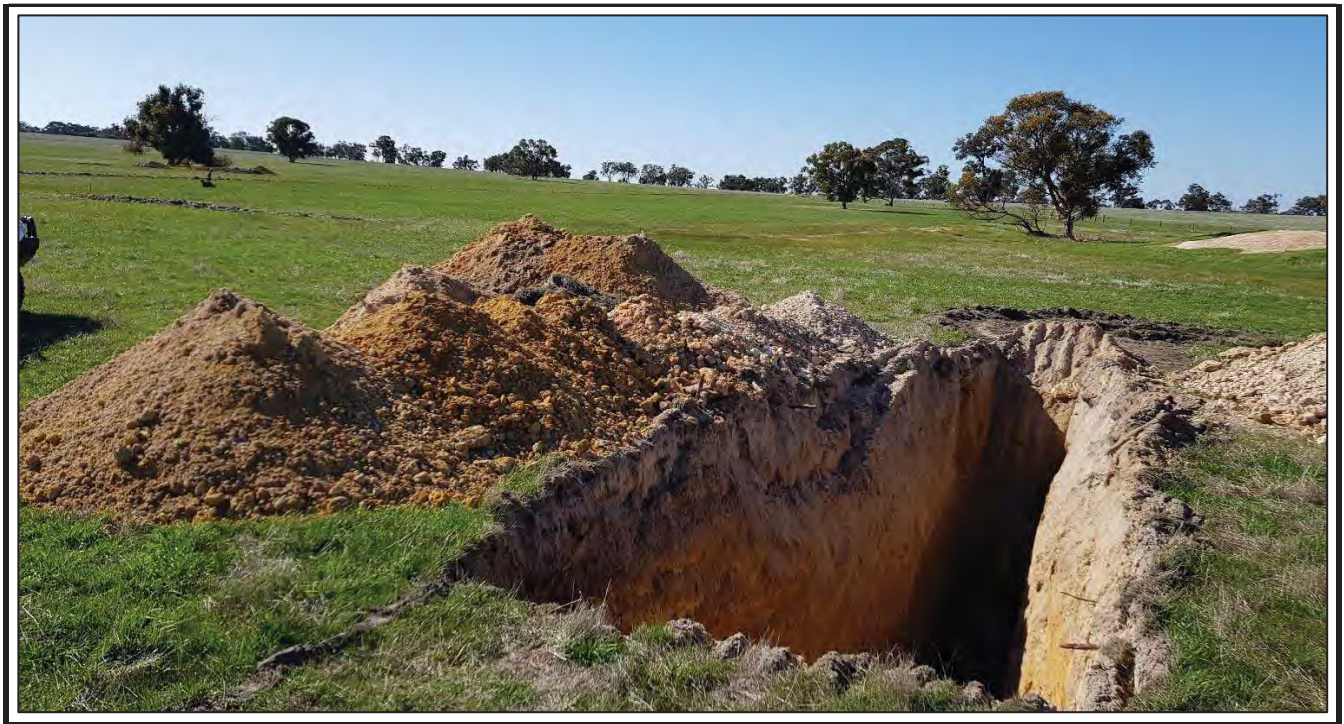
Test Pit No. 24 - Excavation

800 - 2500	1700	Sandy CLAY: Low to medium plasticity, light brown/grey mottled orange.	M	F-St				
2500 - 5200	2700	Sandy CLAY: Low to medium plasticity, light brown/grey mottled orange/pink/white.	D	St				
Comments			Pit Terminated at: (mm) below ground level ✓ or ✕					
			Target Depth ✓ 5200					
			Cave In					
			Refusal					
			Near Refusal					
			Flooding					
			Lack of Reach					
Materials Consistency/Strength		Rock	Cementation		▼ Water Water first Encountered			
Cohesive	Non-Cohesive				Moisture D - Dry M - Moist W - Wet			
VS - Very Soft S - Soft F - Firm St - Stiff VSt - Very Stiff H - Hard	VL - Very Loose L - Loose MD - Medium Dense D - Dense VD - Very Dense CO - Compact	EL - Extremely Low VL - Very Low L - Low M - Medium H - High VH - Very High EH - Extremely High	IN - Indurated PC - Poorly Cemented MC - moderately Cemented WC - Well Cemented		General N/A - Not Applicable N/D - Not Determined

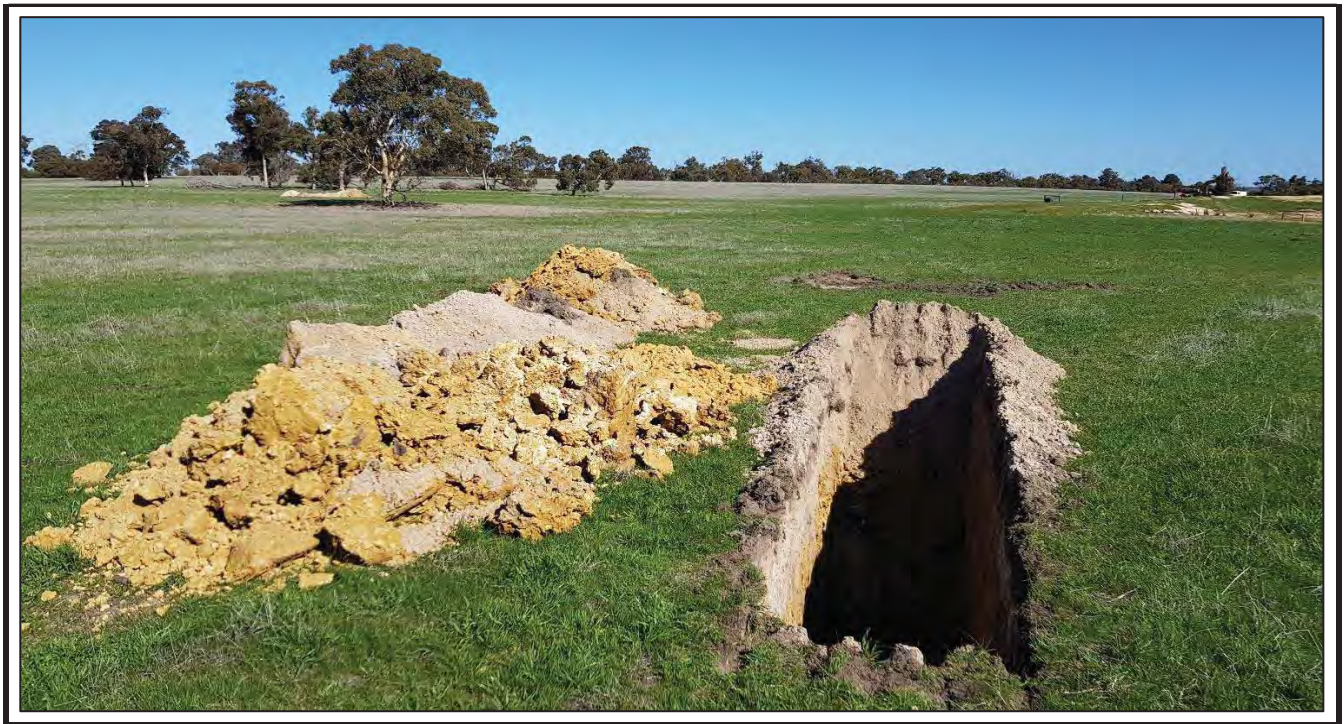
Test Pit No. 25 - Excavation

100 - 300	200	SAND: Light grey, fine to medium.		M	L-MD				
300 - 500	200	Sandy GRAVEL: Light brown/grey, fine to medium, sub rounded. Fine to medium grained sand.		M	MD				
500 - 2000	1500	Sandy CLAY: Low to medium plasticity, light brown/grey mottled orange.		M	F				
Comments				Pit Terminated at: (mm) below ground level ✓ or ✕					
				Target Depth					
				Cave In					
				Refusal					
				Near Refusal					
				Flooding					
				Lack of Reach					
Materials Consistency/Strength				▼ Water Water first Encountered					
Cohesive		Non-Cohesive		Rock		Cementation		Moisture	
VS - Very Soft		VL - Very Loose		EL - Extremely Low		IN - Indurated		D - Dry M - Moist W - Wet	
S - Soft		L - Loose		VL - Very Low		PC - Poorly Cemented			
F - Firm		MD - Medium Dense		L - Low		MC - moderately Cemented			
St - Stiff		D - Dense		M - Medium		WC - Well Cemented			
VSt - Very Stiff		VD - Very Dense		H - High					
H - Hard		CO - Compact		VH - Very High

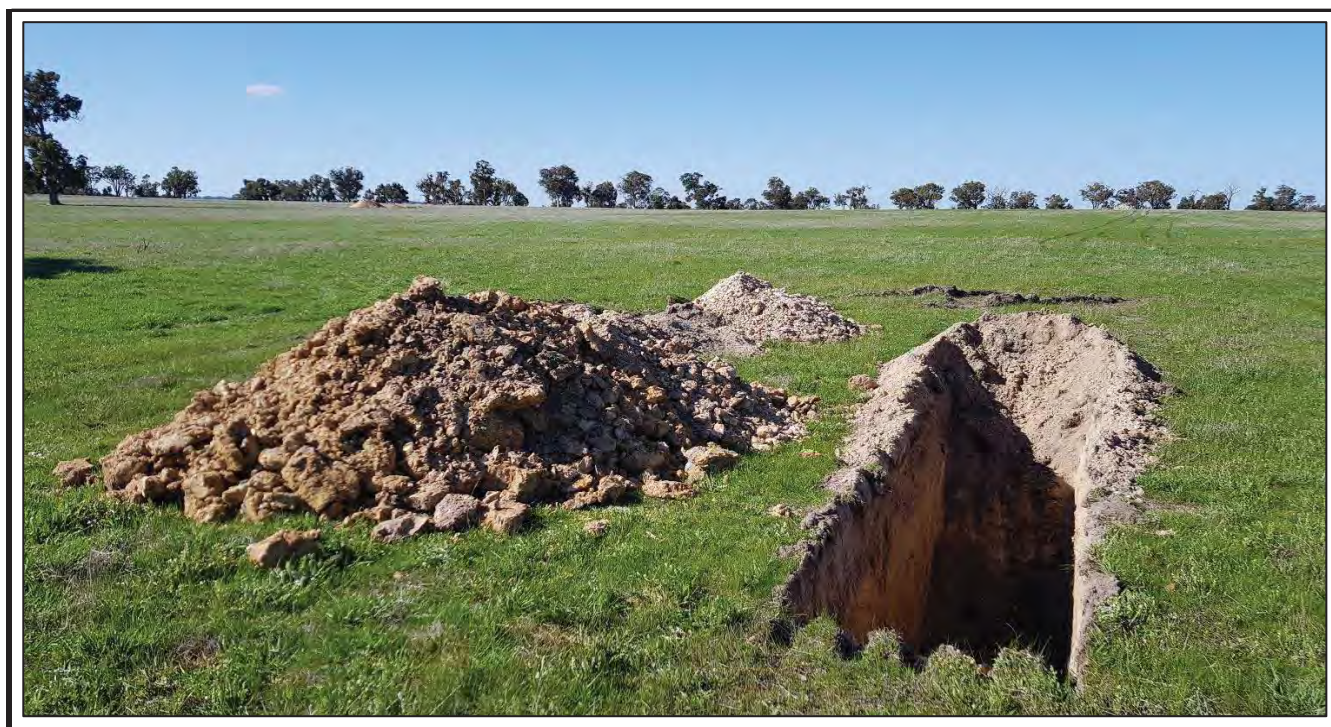
Test Pit No. 29 - Excavation

150 - 300	150	SAND: Grey, fine to medium.	M	L-MD				
300 - 500	200	Sandy GRAVEL: Light brown/grey, fine to coarse, sub rounded. Fine to medium grained sand.	M	MD				
500 - 2000	1500	Sandy CLAY: Low to medium plasticity, light brown/grey mottled orange. Fine to medium grained sand.	M	F-St				
Comments			Pit Terminated at: (mm) below ground level ✓ or ✕					
			Target Depth ✓ 2000					
			Cave In					
			Refusal					
			Near Refusal					
			Flooding					
			Lack of Reach					
Materials Consistency/Strength		Rock	Cementation		▼ Water Water first Encountered			
Cohesive	Non-Cohesive				Moisture D - Dry M - Moist W - Wet			
VS - Very Soft S - Soft F - Firm St - Stiff VSt - Very Stiff H - Hard	VL - Very Loose L - Loose MD - Medium Dense D - Dense VD - Very Dense CO - Compact	EL - Extremely Low VL - Very Low L - Low M - Medium H - High VH - Very High EH - Extremely High	IN - Indurated PC - Poorly Cemented MC - moderately Cemented WC - Well Cemented		General N/A - Not Applicable N/D - Not Determined

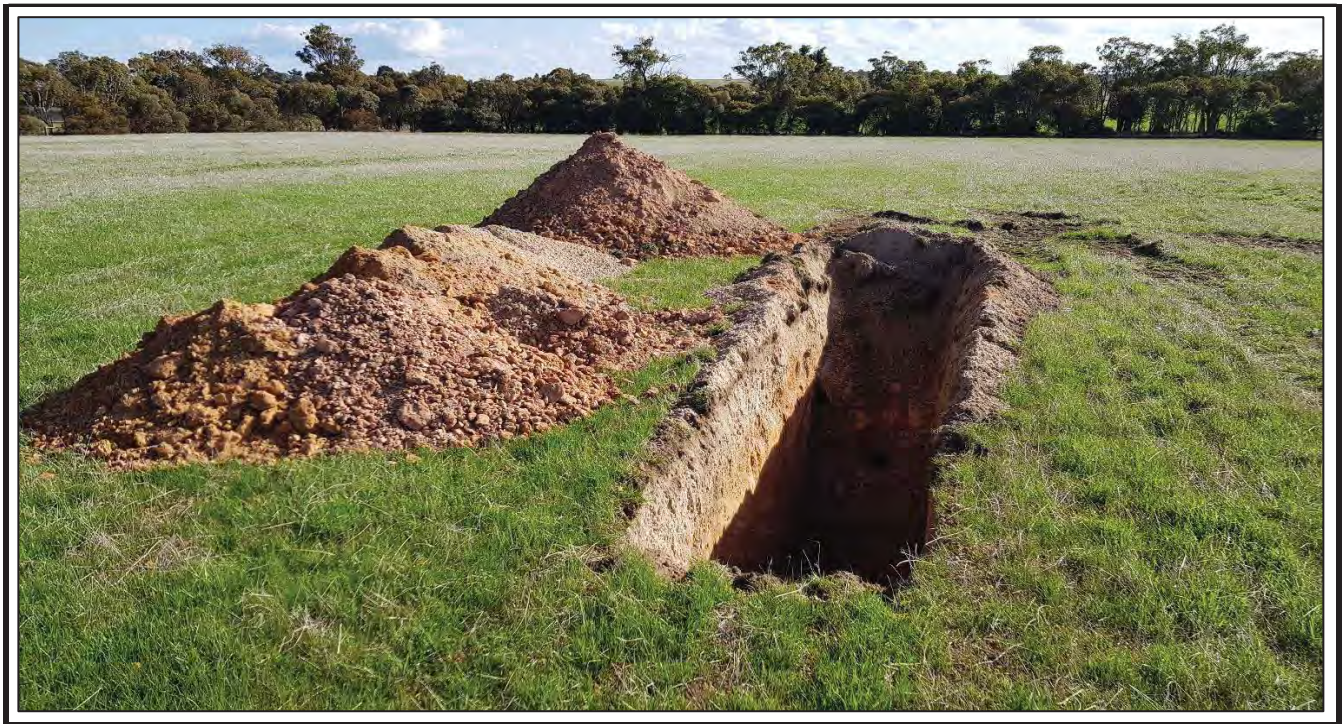
Test Pit No. 31 - Excavation

100 - 650	550	Sandy GRAVEL: Light brown/grey, fine to coarse, sub rounded to sub angular. Fine to medium grained sand.	M	MD				
650 - 2000	1450	Sandy CLAY: Low to medium plasticity, light brown/grey mottled orange/red. Fine to medium grained sand.	M	F-St				
Comments			Pit Terminated at: (mm) below ground level ✓ or ✕					
			Target Depth ✓ 2000					
			Cave In					
			Refusal					
			Near Refusal					
			Flooding					
			Lack of Reach					
Materials Consistency/Strength		Rock	Cementation		▼ Water Water first Encountered			
Cohesive	Non-Cohesive				Moisture D - Dry M - Moist W - Wet			
VS - Very Soft S - Soft F - Firm St - Stiff VSt - Very Stiff H - Hard	VL - Very Loose L - Loose MD - Medium Dense D - Dense VD - Very Dense CO - Compact	EL - Extremely Low VL - Very Low L - Low M - Medium H - High VH - Very High EH - Extremely High	IN - Indurated PC - Poorly Cemented MC - moderately Cemented WC - Well Cemented		General N/A - Not Applicable N/D - Not Determined

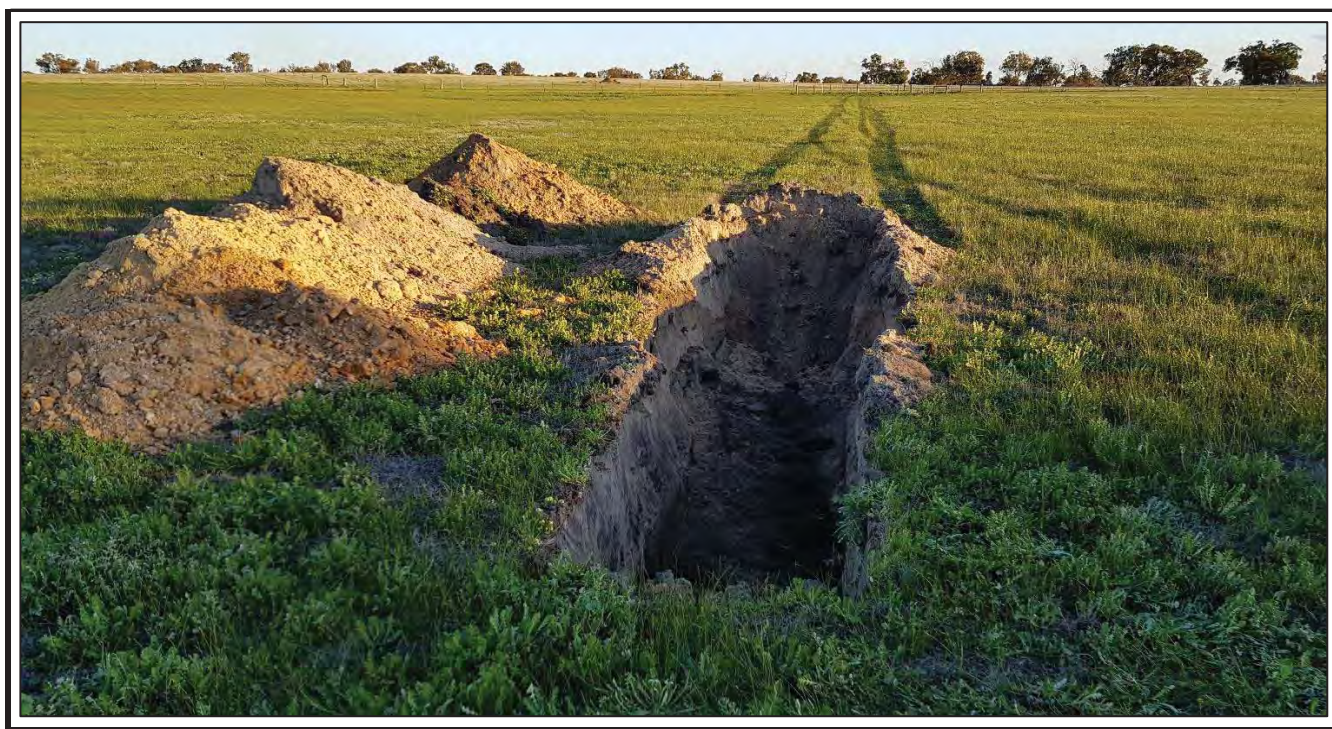
Test Pit No. 34 - Excavation

150 - 950	800	SAND: Light grey, fine to medium.		M	L-MD				
950 - 1800	850	Sandy CLAY: Low to medium plasticity, grey mottled red. Fine to medium grained sand.		M	F-St				
Comments				Pit Terminated at: (mm) below ground level					
				✓ or ✗					
				Target Depth ✓ 1800					
				Cave In					
				Refusal					
				Near Refusal					
				Flooding					
				Lack of Reach					
Materials Consistency/Strength		Rock	Cementation	▼ Water Water first Encountered Moisture D - Dry M - Moist W - Wet General N/A - Not Applicable N/D - Not Determined					
Cohesive VS - Very Soft S - Soft F - Firm St - Stiff VSt - Very Stiff H - Hard	Non-Cohesive VL - Very Loose L - Loose MD - Medium Dense D - Dense VD - Very Dense CO - Compact	EL - Extremely Low VL - Very Low L - Low M - Medium H - High VH - Very High EH - Extremely High	IN - Indurated PC - Poorly Cemented MC - moderately Cemented WC - Well Cemented

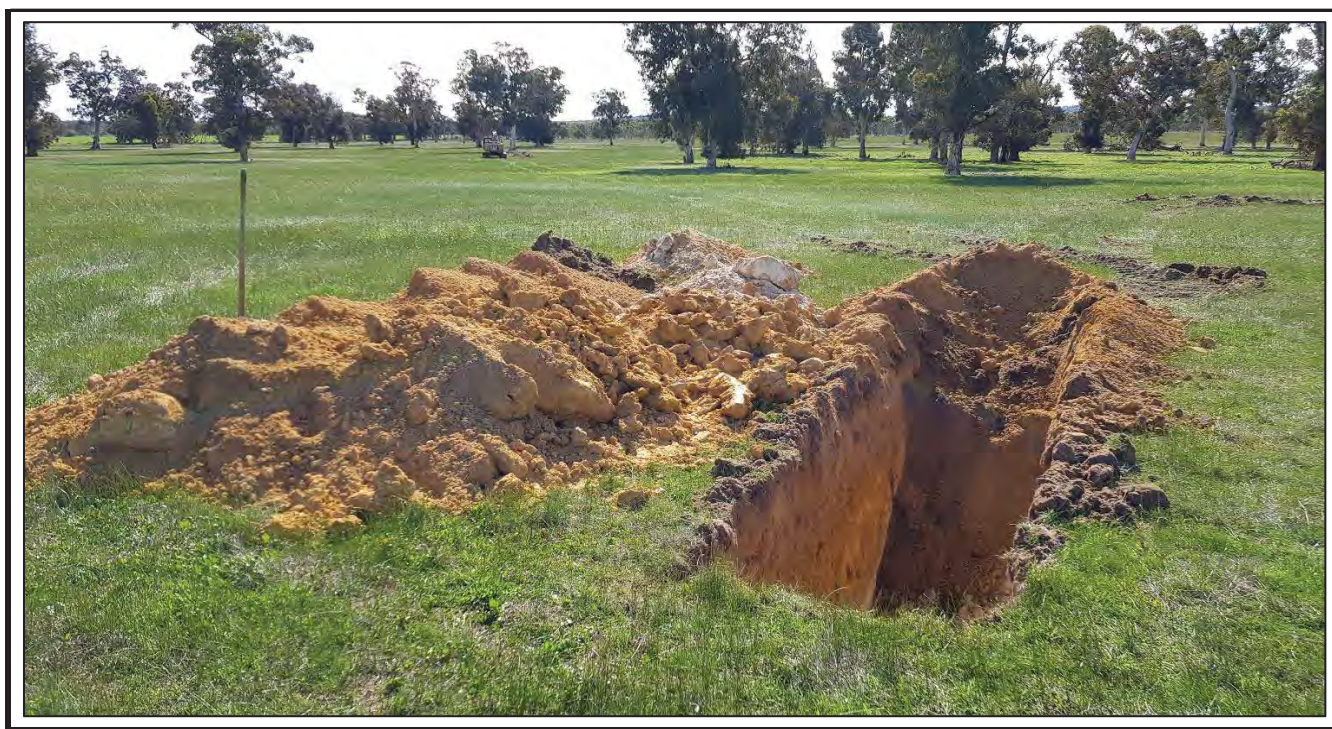
Test Pit No. 36 - Excavation

150 - 500	350	Sandy GRAVEL: Brown, fine to medium, sub rounded. Fine to medium grained sand.	M	MD				
500 - 850	350	Sandy GRAVEL with clay: Low plasticity, brown/orange. Fine to medium, sub rounded gravel. Fine to medium grained sand.	M	MD				
850 - 1700	950	Sandy CLAY: Medium plasticity, light brown/orange to light brown/white.	M	St				
1700 - 2000	300	Clayey SAND with silt: Low plasticity, white. Fine to medium grained sand.	M	St				
Comments			Pit Terminated at: (mm) below ground level ✓ or ✕					
			Target Depth ✓ 2000					
			Cave In <input type="checkbox"/>					
			Refusal <input type="checkbox"/>					
			Near Refusal <input type="checkbox"/>					
			Flooding <input type="checkbox"/>					
			Lack of Reach <input type="checkbox"/>					
Materials Consistency/Strength		Rock	Cementation		▼ Water Water first Encountered			
Cohesive	Non-Cohesive				Moisture D - Dry M - Moist W - Wet			
VS - Very Soft S - Soft F - Firm St - Stiff VSt - Very Stiff H - Hard	VL - Very Loose L - Loose MD - Medium Dense D - Dense VD - Very Dense CO - Compact	EL - Extremely Low VL - Very Low L - Low M - Medium H - High VH - Very High EH - Extremely High	IN - Indurated PC - Poorly Cemented MC - moderately Cemented WC - Well Cemented		General N/A - Not Applicable N/D - Not Determined

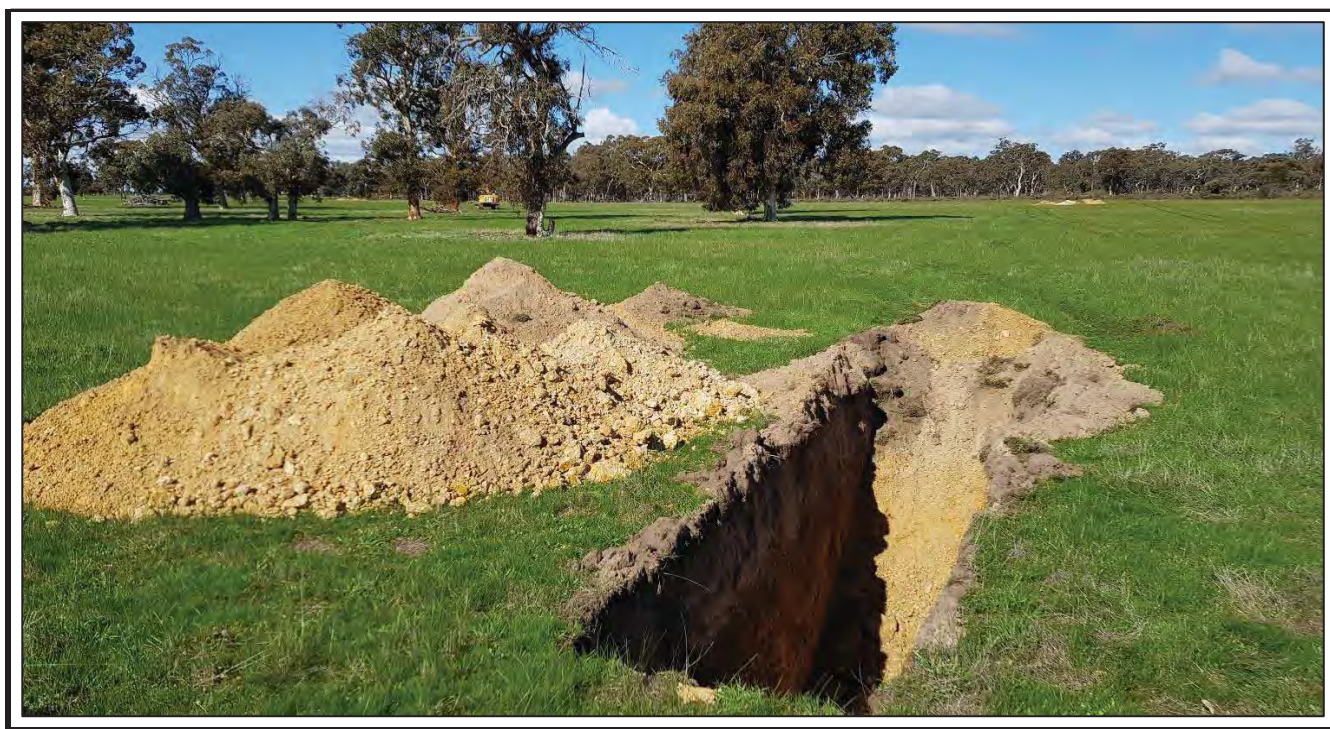
Test Pit No. 37 - Excavation

1100 - 2000	900	Sandy CLAY: Low plasticity, light brown/white mottled orange.	M	F				
Comments			Pit Terminated at: (mm) below ground level ✓ or ✕					
			Target Depth ✓ 2000					
			Cave In <input type="checkbox"/>					
			Refusal <input type="checkbox"/>					
			Near Refusal <input type="checkbox"/>					
			Flooding <input type="checkbox"/>					
			Lack of Reach <input type="checkbox"/>					
Materials Consistency/Strength		Rock	Cementation		▼ Water Water first Encountered			
Cohesive	Non-Cohesive				Moisture D - Dry M - Moist W - Wet			
VS - Very Soft S - Soft F - Firm St - Stiff VSt - Very Stiff H - Hard	VL - Very Loose L - Loose MD - Medium Dense D - Dense VD - Very Dense CO - Compact	EL - Extremely Low VL - Very Low L - Low M - Medium H - High VH - Very High EH - Extremely High	IN - Indurated PC - Poorly Cemented MC - moderately Cemented WC - Well Cemented		General N/A - Not Applicable N/D - Not Determined

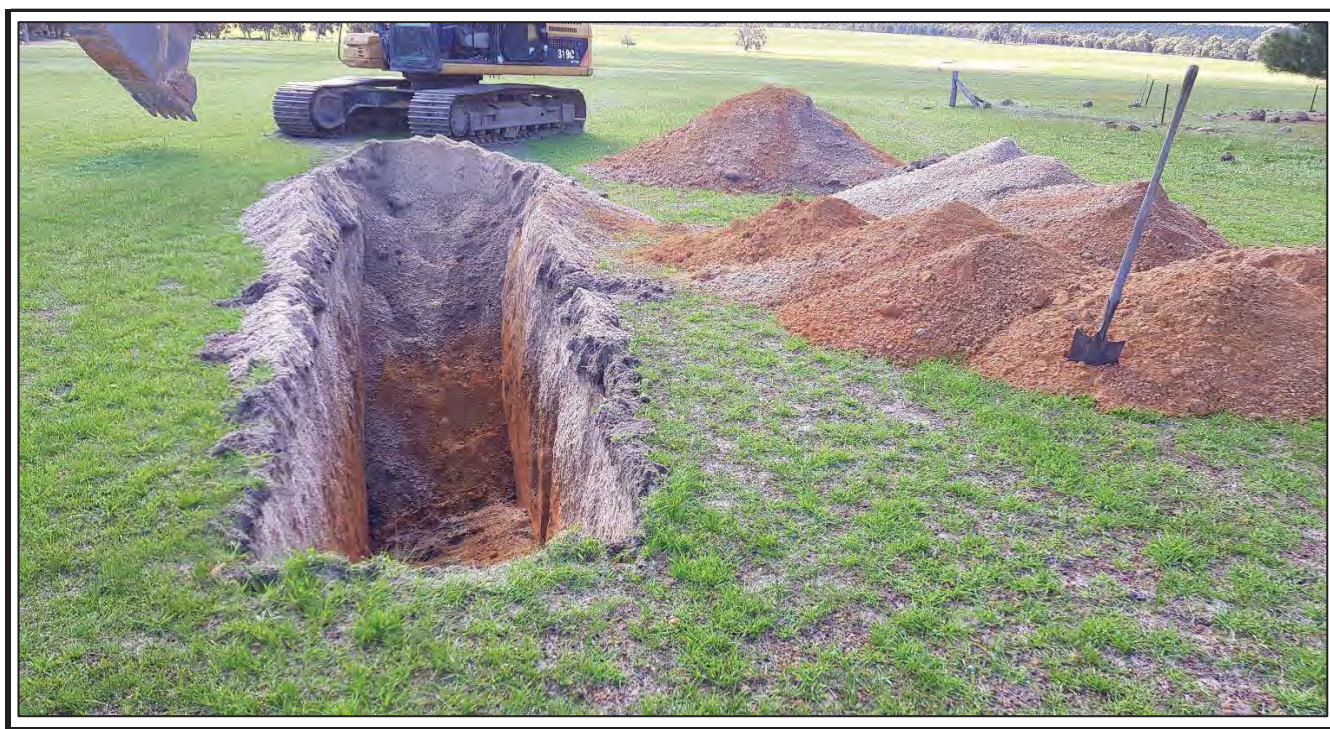
Test Pit No. 38 - Excavation

100 - 750	650	Sandy GRAVEL: Light grey/brown, fine to medium, sub rounded to rounded. Fine to medium grained sand.		M	MD				
750 - 2000	1250	Clayey GRAVEL: Low plasticity, brown/red. Fine to medium, sub rounded gravel.		M	F-St				
Comments				Pit Terminated at: (mm) below ground level					
				✓ or ✕					
				Target Depth					
				Cave In					
				Refusal					
				Near Refusal					
				Flooding					
				Lack of Reach					
Materials Consistency/Strength				<div> <div> <div>Cohesive</div> <div>Non-Cohesive</div> </div> <div> <div>Rock</div> <div>Cementation</div> </div> </div>					
VS - Very Soft S - Soft F - Firm St - Stiff VSt - Very Stiff H - Hard		VL - Very Loose L - Loose MD - Medium Dense D - Dense VD - Very Dense CO - Compact		EL - Extremely Low VL - Very Low L - Low M - Medium H - High VH - Very High EH - Extremely High		IN - Indurated PC - Poorly Cemented MC - moderately Cemented WC - Well Cemented		<div> <div>▼ Water</div> <div>Water first Encountered</div> </div> <div> <div>Moisture</div> <div>D - Dry M - Moist W - Wet</div> </div> <div> <div>General</div> <div>N/A - Not Applicable N/D - Not Determined</div> </div>

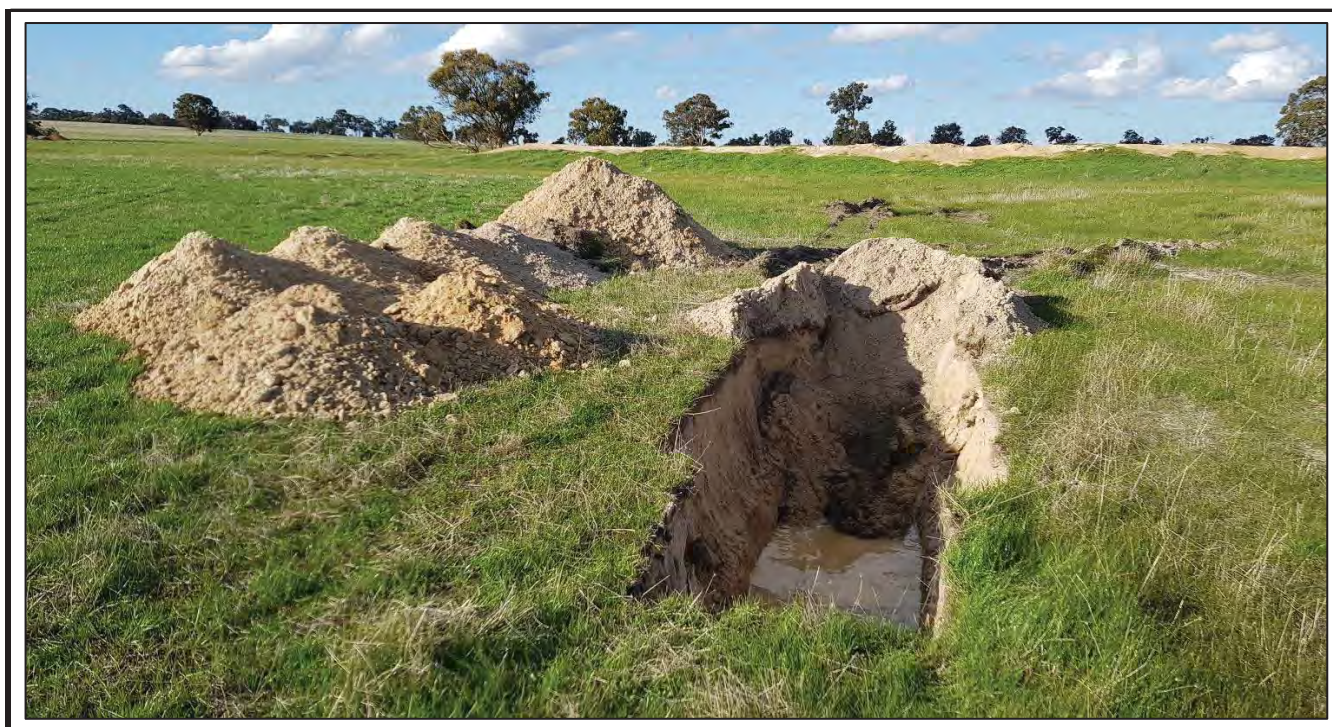
Test Pit No. 42 - Excavation

GREAT SOUTHERN GEOTECHNICS CONSTRUCTION MATERIALS TESTING		Job No	1919	Report	1919/1	Sheet	83	of	108
Client: Fletchers International WA Project: Fletcher Proposed Feedlot Project Project No.: N/A Location: 670 Youngs Road, Beaufort River WA Test Pit No.: TP42 Sample No. 1919G42				Operator/Contractor: GSG Equipment type: Caterpillar 319DI 20 tonne Excavator Excavation Method : 900mm trenching bucket. Position: Refer to site plan					
Date Commenced:		30/07/2019		Logged By:		M.Coffey		Excavation Dimensions:	
				Depth		2.0 (m)		Width 0.9 (m)	
Depth Below Surface (mm)	Layer Depth (mm)	Material Description		Moist. Condition	Consistency / Strength	Cementation	Water Table	Classification Symbol	Sample/Test
		SOIL TYPE, Plasticity, Colour, Particle characteristics, Secondary and other minor components							
0 - 150	150	(Topsoil) SAND with silt: Grey, fine to medium. Roots & root fibres.		M	L-MD		water table at 1100mm below existing ground level 24hrs after excavation

150 - 1000	850	SAND: Light grey, fine to medium, angular to sub angular.		M-W	L-MD				
1000 - 2000	1000	Sandy CLAY: Low to medium plasticity, light brown/grey mottled orange.		M	F-St				
Comments				Pit Terminated at: (mm) below ground level					
				✓ or ✕					
Water seeping in test pit over sandy CLAY layer.				Target Depth					
				Cave In					
				Refusal					
				Near Refusal					
				Flooding					
				Lack of Reach					
Materials Consistency/Strength		Rock	Cementation	▼ Water Water first Encountered Moisture D - Dry M - Moist W - Wet General N/A - Not Applicable N/D - Not Determined					
Cohesive	Non-Cohesive								
VS - Very Soft	VL - Very Loose	EL - Extremely Low	IN - Indurated						
S - Soft	L - Loose	VL - Very Low	PC - Poorly Cemented						
F - Firm	MD - Medium Dense	L - Low	MC - moderately Cemented						
St - Stiff	D - Dense	M - Medium	WC - Well Cemented						
VSt - Very Stiff	VD - Very Dense	H - High

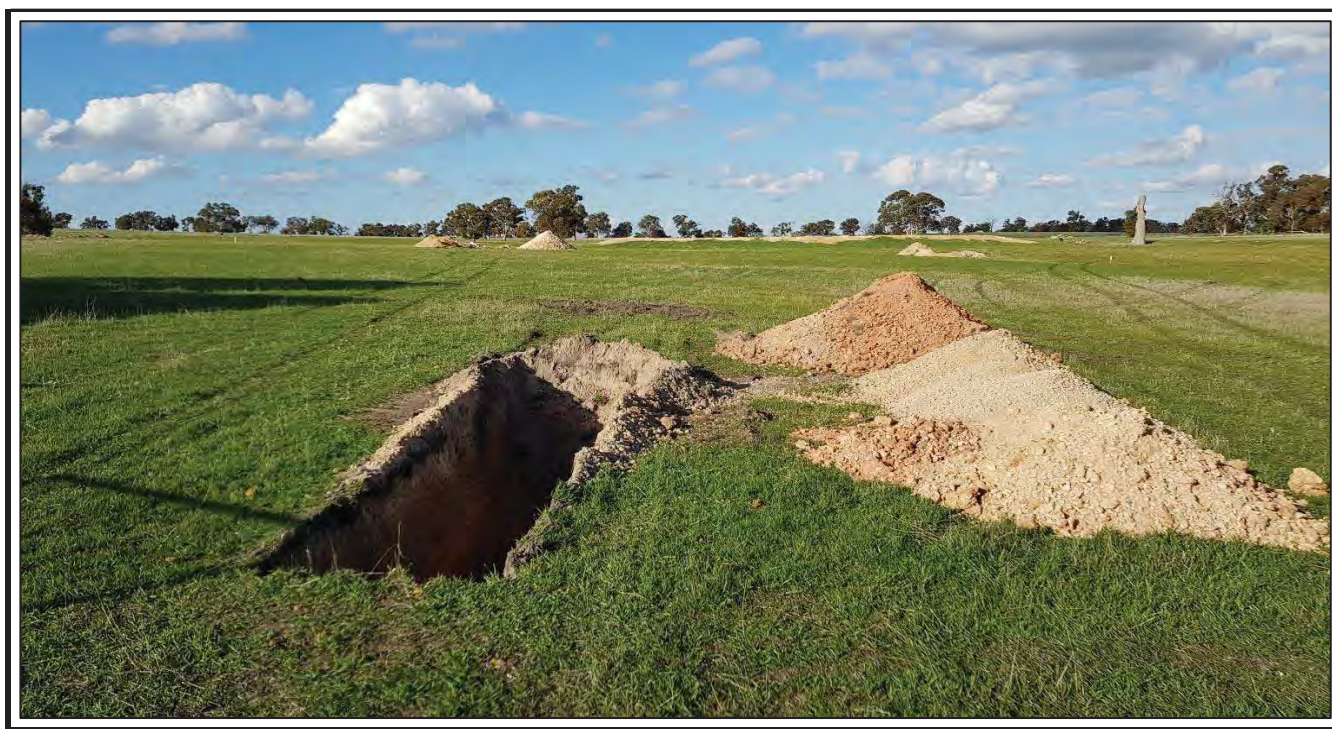
Test Pit No. 43 - Excavation

GREAT SOUTHERN GEOTECHNICS CONSTRUCTION MATERIALS TESTING		Job No	1919	Report	1919/1	Sheet	85	of	108
Client: Fletchers International WA Project: Fletcher Proposed Feedlot Project Project No.: N/A Location: 670 Youngs Road, Beaufort River WA Test Pit No.: TP43 Sample No. 1919G43				Operator/Contractor: GSG Equipment type: Caterpillar 319DI 20 tonne Excavator Excavation Method : 900mm trenching bucket. Position: Refer to site plan					
Date Commenced:		30/07/2019		Logged By:		M.Coffey		Excavation Dimensions:	
				Depth		2.0 (m)		Width 0.9 (m)	
Depth Below Surface (mm)	Layer Depth (mm)	Material Description		Moist. Condition	Consistency / Strength	Cementation	Water Table	Classification Symbol	Sample/Test
		SOIL TYPE, Plasticity, Colour, Particle characteristics, Secondary and other minor components							
0 - 150	150	(Topsoil) SAND with silt: Grey, fine to medium. Roots & root fibres.		M	L-MD		No water table encountered.

150 - 400	250	Gravelly SAND: Light grey/brown, fine to medium. Fine to medium, sub rounded to sub angular gravel.		M	MD				
400 - 700	300	Sandy GRAVEL: Brown/orange, fine to medium, sub rounded to sub angular. Fine to medium grained sand.		M	MD				
700 - 900	200	Sandy GRAVEL: Brown/grey, fine to medium, sub rounded to sub angular. Fine to medium grained sand.		M-W	MD				
900 - 2000	1100	Sandy CLAY: Low to medium plasticity, grey mottled red. Fine to medium grained sand.		M	F-St				
Comments				Pit Terminated at: (mm) below ground level ✓ or ✕					
				Target Depth ✓ 2000					
				Cave In					
				Refusal					
				Near Refusal					
				Flooding					
				Lack of Reach					
Materials Consistency/Strength		Rock	Cementation	▼ Water Water first Encountered Moisture D - Dry M - Moist W - Wet General N/A - Not Applicable N/D - Not Determined					
Cohesive VS - Very Soft S - Soft F - Firm St - Stiff VSt - Very Stiff H - Hard	Non-Cohesive VL - Very Loose L - Loose MD - Medium Dense D - Dense VD - Very Dense CO - Compact	EL - Extremely Low VL - Very Low L - Low M - Medium H - High VH - Very High EH - Extremely High	IN - Indurated PC - Poorly Cemented MC - moderately Cemented WC - Well Cemented

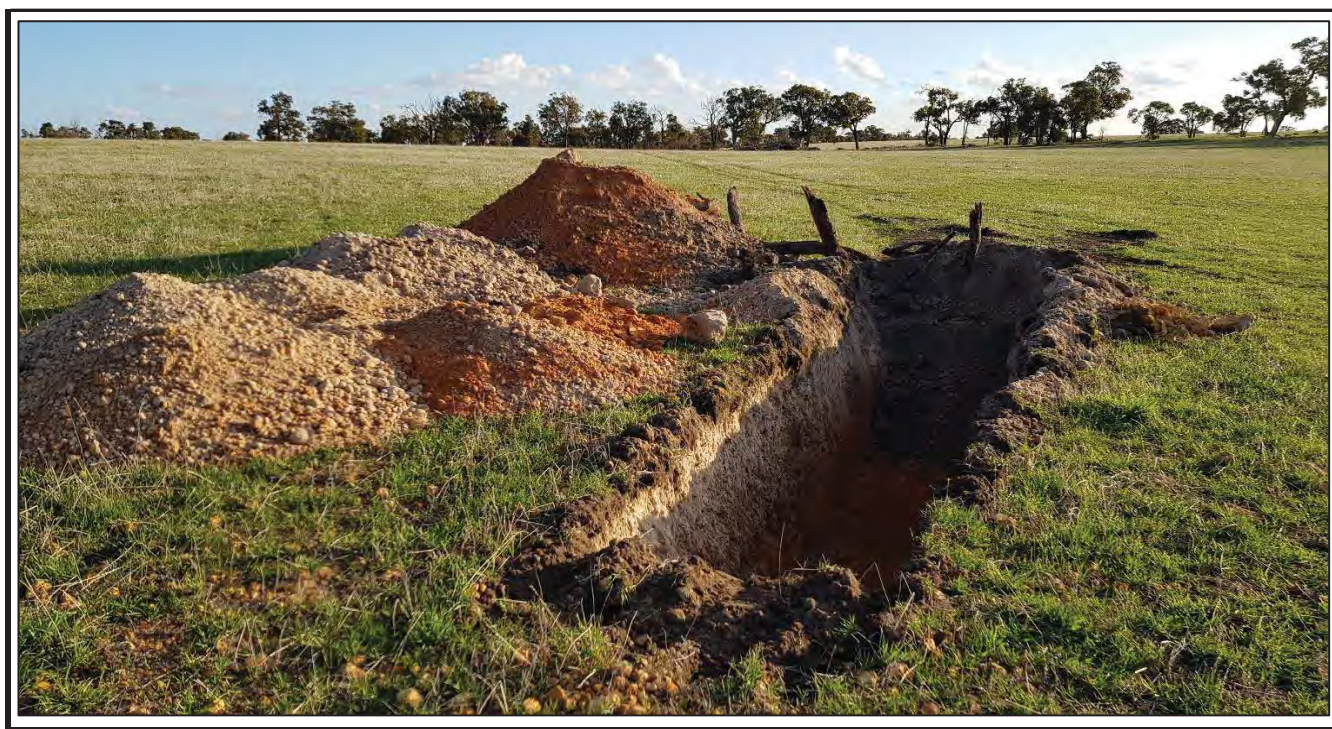
Test Pit No. 46 - Excavation

GREAT SOUTHERN GEOTECHNICS CONSTRUCTION MATERIALS TESTING		Job No	1919	Report	1919/1	Sheet	91	of	108
Client: Fletchers International WA Project: Fletcher Proposed Feedlot Project Project No.: N/A Location: 670 Youngs Road, Beaufort River WA Test Pit No.: TP46 Sample No. 1919G46				Operator/Contractor: GSG Equipment type: Caterpillar 319DI 20 tonne Excavator Excavation Method : 900mm trenching bucket. Position: Refer to site plan					
Date Commenced:		29/07/2019		Logged By:		M.Coffey		Excavation Dimensions:	
				Depth		1.6 (m)		Width 0.9 (m)	
Depth Below Surface (mm)	Layer Depth (mm)	Material Description		Moist. Condition	Consistency / Strength	Cementation	Water Table	Classification Symbol	Sample/Test
		SOIL TYPE, Plasticity, Colour, Particle characteristics, Secondary and other minor components							
0 - 150	150	(Topsoil) SAND with silt: Grey, fine to medium. Roots & root fibres.		M	L-MD		No water table encountered.

150 - 1000	850	Sandy GRAVEL: Light brown/grey, fine to coarse, sub rounded to sub angular. diameter.		M	MD-D				
1000 - 1200	200	Sandy GRAVEL: Brown/orange, fine to medium, sub rounded to sub angular. Fine to medium grained sand.		M	MD				
1200 - 1600	400	Sandy CLAY: Low to medium plasticity, light brown/orange mottled red. Fine to medium grained sand.		M	F-St				
Comments				Pit Terminated at: (mm) below ground level					
				✓ or ✕					
Cobbles & boulders could be seen across the surface in this area.				Target Depth ✓ 1600					
				Cave In					
				Refusal					
				Near Refusal					
				Flooding					
				Lack of Reach					
Materials Consistency/Strength		Rock	Cementation	▼ Water Water first Encountered Moisture D - Dry M - Moist W - Wet General N/A - Not Applicable N/D - Not Determined					
Cohesive VS - Very Soft S - Soft F - Firm St - Stiff VSt - Very Stiff H - Hard	Non-Cohesive VL - Very Loose L - Loose MD - Medium Dense D - Dense VD - Very Dense CO - Compact	EL - Extremely Low VL - Very Low L - Low M - Medium H - High VH - Very High EH - Extremely High	IN - Indurated PC - Poorly Cemented MC - moderately Cemented WC - Well Cemented

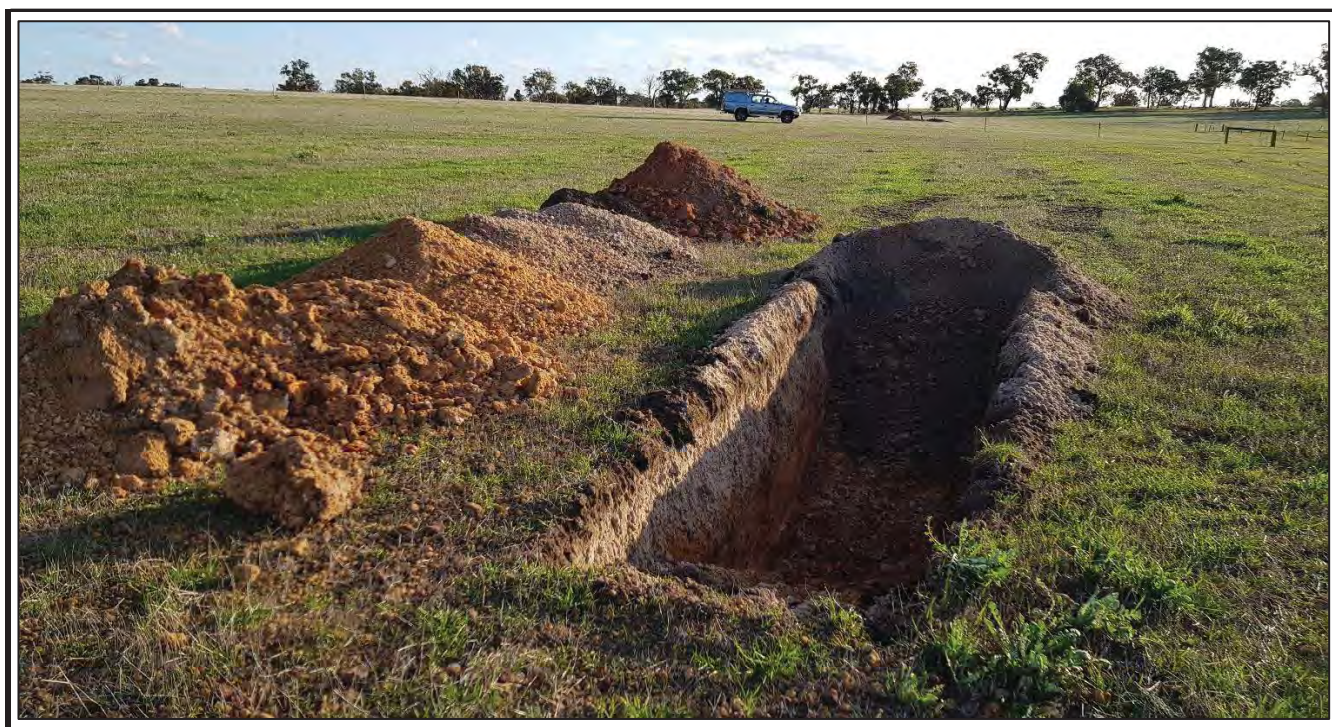
Test Pit No. 47 - Excavation

GREAT SOUTHERN GEOTECHNICS CONSTRUCTION MATERIALS TESTING		Job No	1919	Report	1919/1	Sheet	93	of	108
Client: Fletchers International WA Project: Fletcher Proposed Feedlot Project Project No.: N/A Location: 670 Youngs Road, Beaufort River WA Test Pit No.: TP47 Sample No. 1919G47				Operator/Contractor: GSG Equipment type: Caterpillar 319DI 20 tonne Excavator Excavation Method : 900mm trenching bucket. Position: Refer to site plan					
Date Commenced:		30/07/2019		Logged By:		M.Coffey		Excavation Dimensions:	
				Depth		1.2 (m)		Width 0.9 (m)	
Depth Below Surface (mm)	Layer Depth (mm)	Material Description		Moist. Condition	Consistency / Strength	Cementation	Water Table	Classification Symbol	Sample/Test
		SOIL TYPE, Plasticity, Colour, Particle characteristics, Secondary and other minor components							
0 - 150	150	(Topsoil) SAND with silt: Grey, fine to medium. Roots & root fibres.		M	L-MD		No water table encountered.

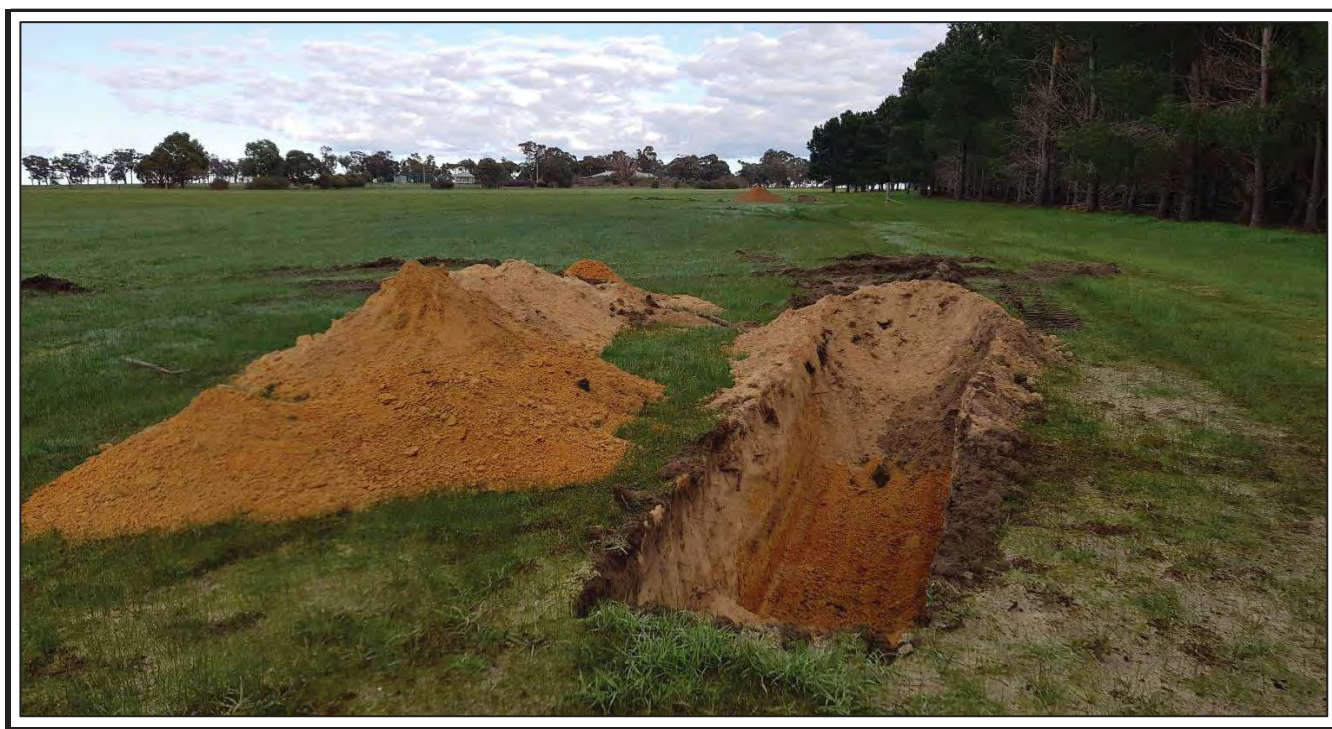
Test Pit No. 50 - Excavation

GREAT SOUTHERN GEOTECHNICS CONSTRUCTION MATERIALS TESTING		Job No	1919	Report	1919/1	Sheet	99	of	108
Client: Fletchers International WA Project: Fletcher Proposed Feedlot Project Project No.: N/A Location: 670 Youngs Road, Beaufort River WA Test Pit No.: TP50 Sample No. 1919G50				Operator/Contractor: GSG Equipment type: Caterpillar 319DI 20 tonne Excavator Excavation Method : 900mm trenching bucket. Position: Refer to site plan					
Date Commenced: 31/07/2019		Logged By: M.Coffey		Excavation Dimensions: Depth 1.2 (m) Width 0.9 (m)					
Depth Below Surface (mm)	Layer Depth (mm)	Material Description		Moist. Condition	Consistency / Strength	Cementation	Water Table	Classification Symbol	Sample/Test
0 - 100	100	(Topsoil) SAND with silt: Grey, fine to medium. Roots & root fibres.		M	L-MD		No water table encountered.		
100 - 500	400	SAND: Light brown/white, fine to medium.		M	L-MD				
500 - 1200	700	Sandy CLAY with gravel: Low to medium plasticity, brown/orange. Fine to medium, sub rounded to sub angular. Fine to medium grained sand.		M	F

Comments				Pit Terminated at: (mm) below ground level ✓ or ✕					
				Target Depth ✓ 1200					
				Cave In					
				Refusal					
				Near Refusal					
				Flooding					
				Lack of Reach					
Materials Consistency/Strength		Rock	Cementation	▼ Water Water first Encountered					
Cohesive VS - Very Soft S - Soft F - Firm St - Stiff VSt - Very Stiff H - Hard	Non-Cohesive VL - Very Loose L - Loose MD - Medium Dense D - Dense VD - Very Dense CO - Compact	EL - Extremely Low VL - Very Low L - Low M - Medium H - High VH - Very High EH - Extremely High	IN - Indurated PC - Poorly Cemented MC - moderately Cemented WC - Well Cemented	Moisture D - Dry M - Moist W - Wet					
				General N/A - Not Applicable N/D - Not Determined

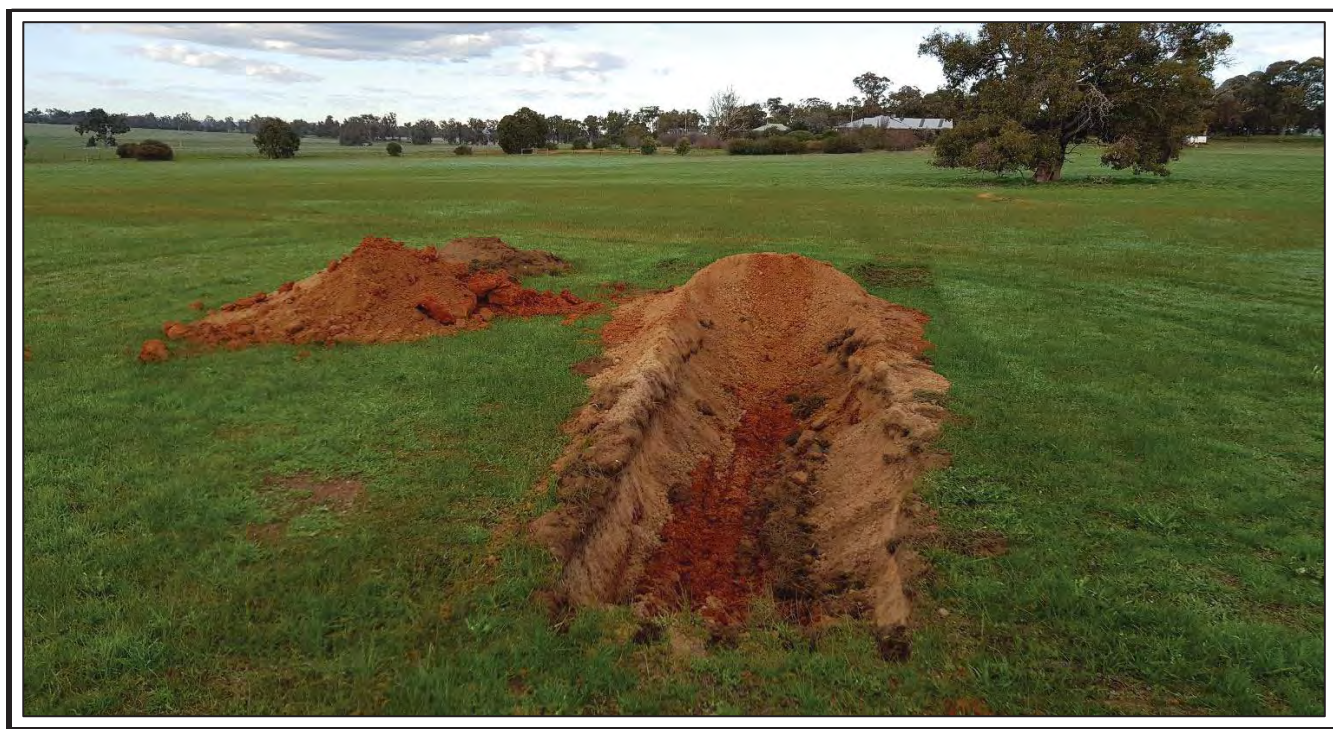
Test Pit No. 51 - Excavation

GREAT SOUTHERN GEOTECHNICS CONSTRUCTION MATERIALS TESTING		Job No	1919	Report	1919/1	Sheet	101	of	108
Client: Fletchers International WA Project: Fletcher Proposed Feedlot Project Project No.: N/A Location: 670 Youngs Road, Beaufort River WA Test Pit No.: TP51 Sample No. 1919G51				Operator/Contractor: GSG Equipment type: Caterpillar 319DI 20 tonne Excavator Excavation Method : 900mm trenching bucket. Position: Refer to site plan					
Date Commenced:		29/07/2019		Logged By:		M.Coffey		Excavation Dimensions:	
				Depth		0.55 (m)		Width 0.9 (m)	
Depth Below Surface (mm)	Layer Depth (mm)	Material Description		Moist. Condition	Consistency / Strength	Cementation	Water Table	Classification Symbol	Sample/Test
		SOIL TYPE, Plasticity, Colour, Particle characteristics, Secondary and other minor components							
0 - 150	150	(Topsoil) SAND with silt: Grey/brown, fine to medium. Roots & root fibres.		M	L-MD		No water table encountered.

150 - 400	250	Sandy GRAVEL: Light brown, fine to medium, sub rounded. Fine to medium grained sand.		M	MD				
400 - 550	150	Sandy CLAY: Medium to high plasticity, red mottled light brown. Fine to medium grained sand.		M	F				
Comments				Pit Terminated at: (mm) below ground level					
				✓ or ✕					
				Target Depth ✓ 550					
				Cave In					
				Refusal					
				Near Refusal					
				Flooding					
				Lack of Reach					
Materials Consistency/Strength		Rock	Cementation	▼ Water Water first Encountered Moisture D - Dry M - Moist W - Wet General N/A - Not Applicable N/D - Not Determined					
Cohesive VS - Very Soft S - Soft F - Firm St - Stiff VSt - Very Stiff H - Hard	Non-Cohesive VL - Very Loose L - Loose MD - Medium Dense D - Dense VD - Very Dense CO - Compact	EL - Extremely Low VL - Very Low L - Low M - Medium H - High VH - Very High EH - Extremely High	IN - Indurated PC - Poorly Cemented MC - moderately Cemented WC - Well Cemented

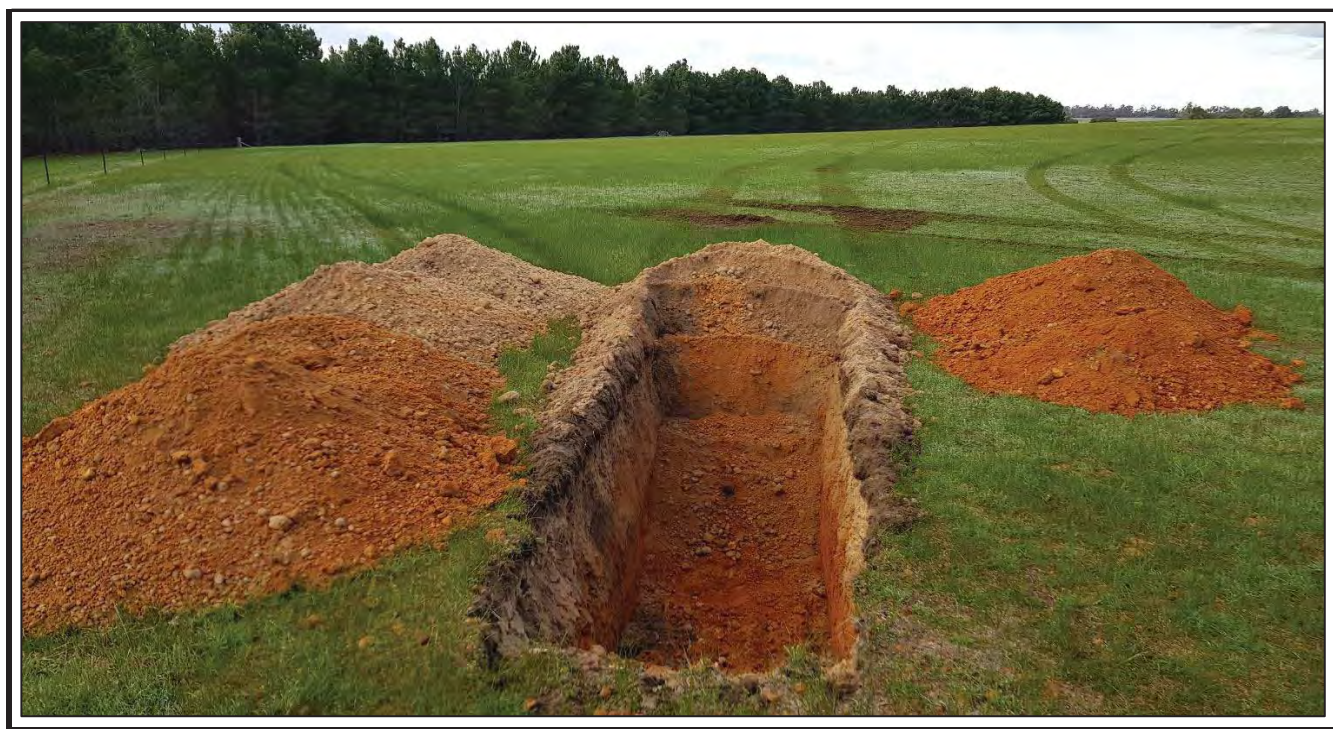
Test Pit No. 52 - Excavation

GREAT SOUTHERN GEOTECHNICS CONSTRUCTION MATERIALS TESTING		Job No 1919	Report 1919/1	Sheet 103 of 108				
Client: Fletchers International WA Project: Fletcher Proposed Feedlot Project Project No.: N/A Location: 670 Youngs Road, Beaufort River WA Test Pit No.: TP52 Sample No. 1919G52		Operator/Contractor: GSG Equipment type: Caterpillar 319DI 20 tonne Excavator Excavation Method : 900mm trenching bucket. Position: Refer to site plan						
Date Commenced: 31/07/2019		Logged By: M.Coffey		Excavation Dimensions: Depth 1.6 (m) Width 0.9 (m)				
Depth Below Surface (mm)	Layer Depth (mm)	Material Description <small>SOIL TYPE, Plasticity, Colour, Particle characteristics, Secondary and other minor components</small>	Moist. Condition	Consistency / Strength	Cementation	Water Table	Classification Symbol	Sample/Test
0 - 150	150	(Topsoil) SAND with silt: Grey, fine to medium. Roots & root fibres.	M	L-MD		No water table encountered.

150 - 500	350	Sandy GRAVEL: Light brown/grey, fine to coarse, sub rounded to sub angular. Fine to medium grained sand.	M	MD				
500 - 850	350	Sandy CLAY with gravel: Low to medium plasticity, brown/orange. Fine to medium, sub rounded to sub angular. Fine to medium grained sand.	M	F				
850 - 1400	550	Sandy CLAY: Low to medium plasticity, orange/red. Fine to medium grained sand.	M	F-St				
Comments			Pit Terminated at: (mm) below ground level ✓ or ✕					
			Target Depth ✓ 1400					
			Cave In					
			Refusal					
			Near Refusal					
			Flooding					
			Lack of Reach					
Materials Consistency/Strength		Rock	Cementation		▼ Water Water first Encountered			
Cohesive	Non-Cohesive				Moisture D - Dry M - Moist W - Wet			
VS - Very Soft S - Soft F - Firm St - Stiff VSt - Very Stiff H - Hard	VL - Very Loose L - Loose MD - Medium Dense D - Dense VD - Very Dense CO - Compact	EL - Extremely Low VL - Very Low L - Low M - Medium H - High VH - Very High EH - Extremely High	IN - Indurated PC - Poorly Cemented MC - moderately Cemented WC - Well Cemented		General N/A - Not Applicable N/D - Not Determined

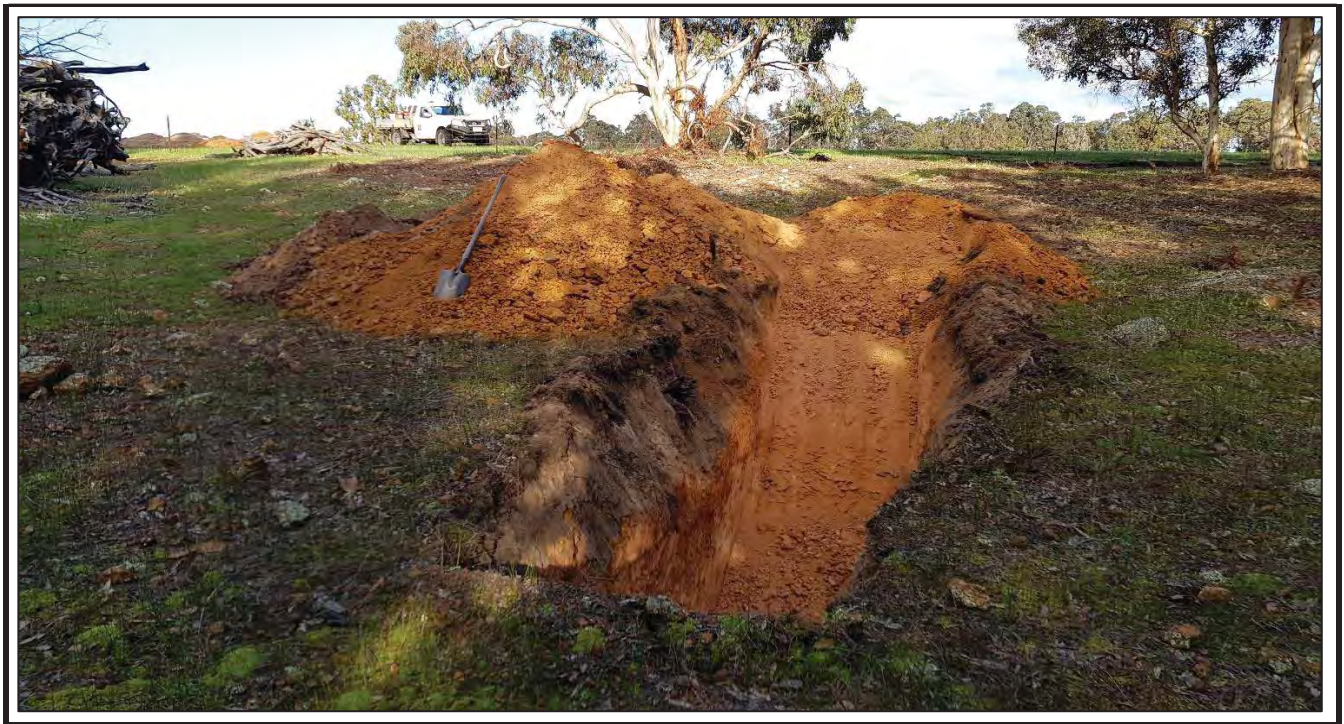
Test Pit No. 53 - Excavation

GREAT SOUTHERN GEOTECHNICS CONSTRUCTION MATERIALS TESTING		Job No	1919	Report	1919/1	Sheet	105	of	108
Client: Fletchers International WA Project: Fletcher Proposed Feedlot Project Project No.: N/A Location: 670 Youngs Road, Beaufort River WA Test Pit No.: TP53 Sample No. 1919G53				Operator/Contractor: GSG Equipment type: Caterpillar 319DI 20 tonne Excavator Excavation Method : 900mm trenching bucket. Position: Refer to site plan					
Date Commenced:		31/07/2019		Logged By:		M.Coffey		Excavation Dimensions:	
				Depth		2.0 (m)		Width 0.9 (m)	
Depth Below Surface (mm)	Layer Depth (mm)	Material Description		Moist. Condition	Consistency / Strength	Cementation	Water Table	Classification Symbol	Sample/Test
		SOIL TYPE, Plasticity, Colour, Particle characteristics, Secondary and other minor components							
0 - 150	150	(Topsoil) SAND with silt: Grey, fine to medium. Roots & root fibres.		M	L-MD		No water table encountered.
