SHIRE OF WOODANILLING

SPECIAL MEETING OF COUNCIL Agenda 2 June 2020

A Special Council Meeting has been called by resolution of Council for 4pm on 2 June 2020 at the Recreation Pavilion on Yairabin Street Woodanilling. The purpose of the meeting is to consider the Feedlot Development Application for Lots 1 & 4 Youngs Road Beaufort River.

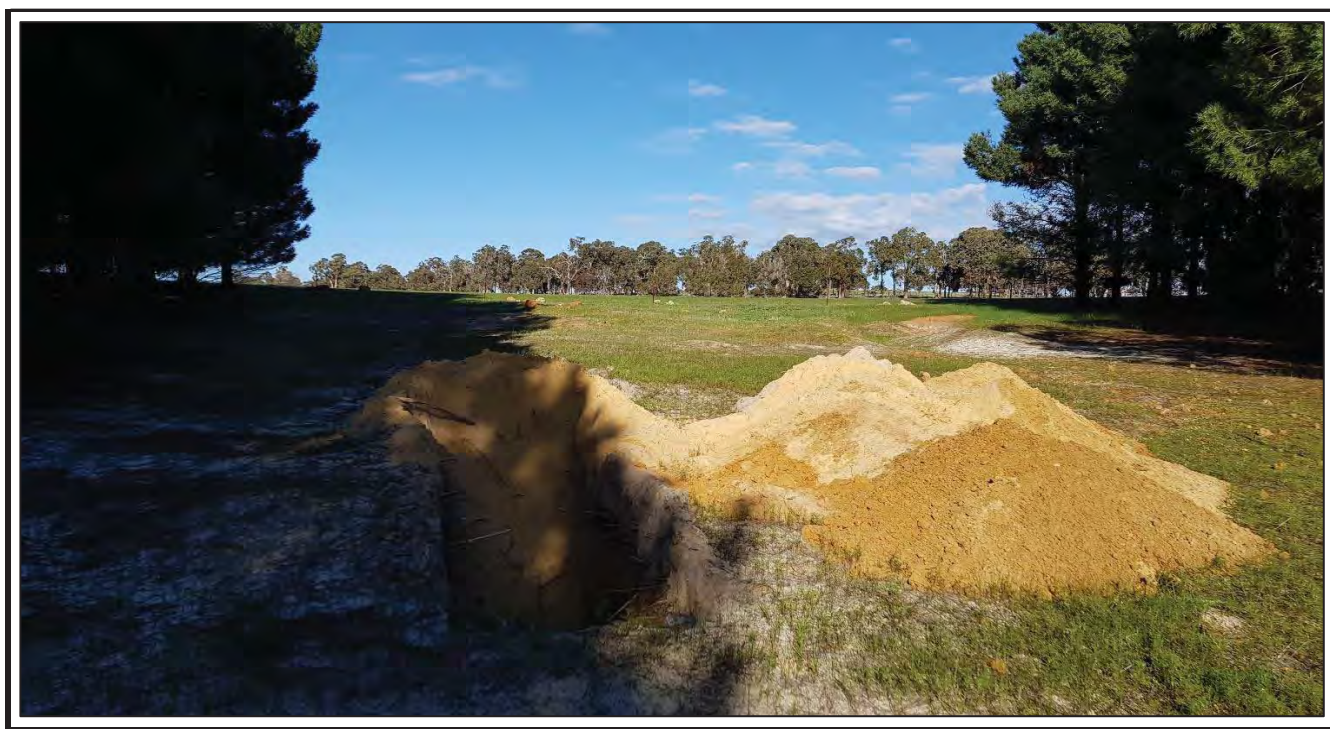
Test Pit No. 54 - Excavation

GREAT SOUTHERN GEOTECHNICS CONSTRUCTION MATERIALS TESTING		Job No 1919	Report 1919/1	Sheet 107 of 108				
Client: Fletchers International WA Project: Fletcher Proposed Feedlot Project Project No.: N/A Location: 670 Youngs Road, Beaufort River WA Test Pit No.: TP54 Sample No. 1919G54		Operator/Contractor: GSG Equipment type: Caterpillar 319DI 20 tonne Excavator Excavation Method : 900mm trenching bucket. Position: Refer to site plan						
Date Commenced: 31/07/2019		Logged By: M.Coffey		Excavation Dimensions: Depth 2.0 (m) Width 0.9 (m)				
Depth Below Surface (mm)	Layer Depth (mm)	Material Description <small>SOIL TYPE, Plasticity, Colour, Particle characteristics, Secondary and other minor components</small>	Moist. Condition	Consistency / Strength	Cementation	Water Table	Classification Symbol	Sample/Test
0 - 100	100	(Topsoil) SAND with silt: Grey, fine to medium. Roots & root fibres.	M	L-MD		No water table encountered.

100 - 750	650	SAND: Yellow, fine to medium.	M	L-MD				
750 - 1600	850	Sandy GRAVEL: Yellow/light brown. Fine to medium, sub rounded to sub angular Fine to medium grained sand.	M	MD				
1600 - 2000	400	Sandy CLAY with gravel: Low to medium plasticity, light brown/red. Fine to medium, sub rounded to sub angular. Fine to medium grained sand.	M	F				
Comments			Pit Terminated at: (mm) below ground level ✓ or ✕					
			Target Depth ✓ 2000					
			Cave In					
			Refusal					
			Near Refusal					
			Flooding					
			Lack of Reach					
Materials Consistency/Strength		Rock	Cementation		▼ Water Water first Encountered			
Cohesive	Non-Cohesive				Moisture D - Dry M - Moist W - Wet			
VS - Very Soft S - Soft F - Firm St - Stiff VSt - Very Stiff H - Hard	VL - Very Loose L - Loose MD - Medium Dense D - Dense VD - Very Dense CO - Compact	EL - Extremely Low VL - Very Low L - Low M - Medium H - High VH - Very High EH - Extremely High	IN - Indurated PC - Poorly Cemented MC - moderately Cemented WC - Well Cemented		General N/A - Not Applicable N/D - Not Determined

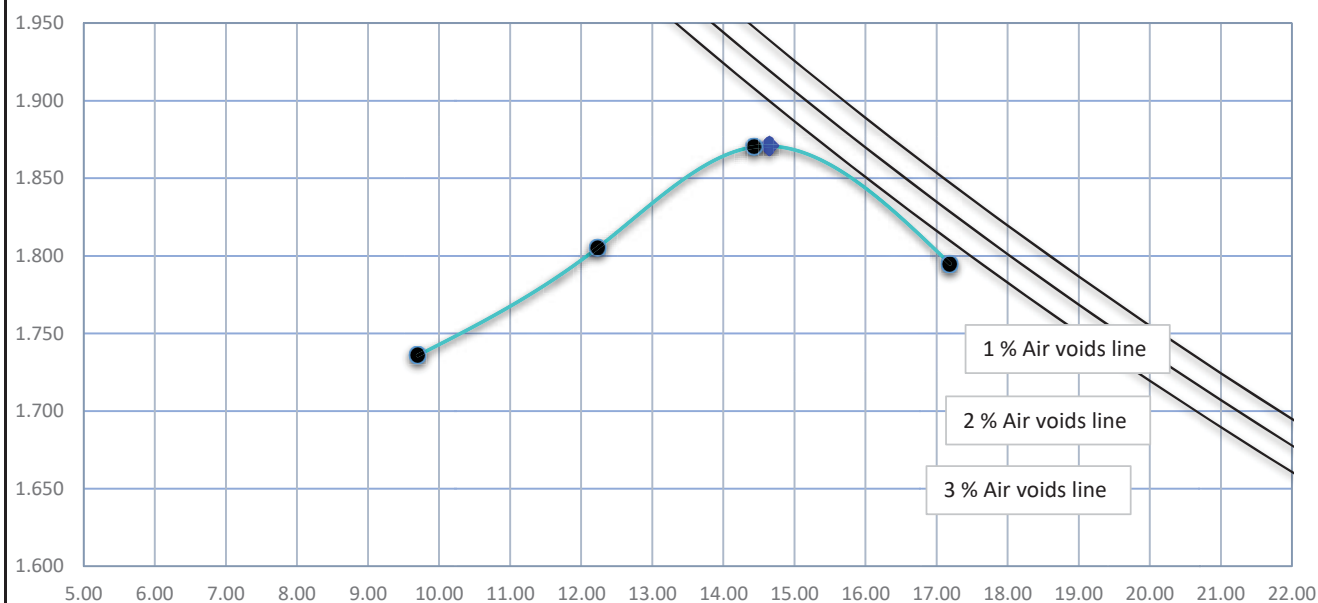
Dry Density (t/m³)

Maximum Dry Density (t/m ³)	1.87
Optimum Moisture Content (%)	14.5

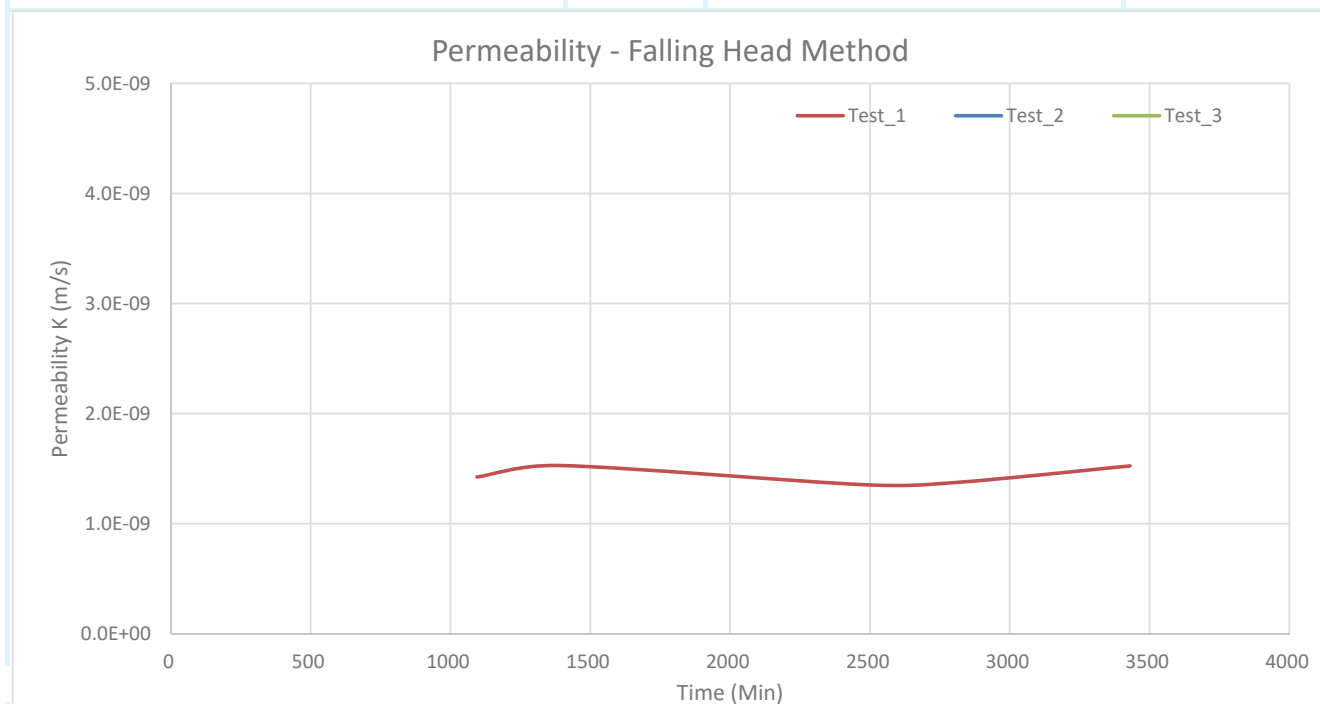
Laboratory Density Ratio (%)	94.3	Laboratory Moisture Ratio (%)	98.9
Compactive Effort	Modified	% Retained on 19mm Sieve	0.0
Surcharge (kPa)	3	Date tested	22/08/2019

Coefficient of Permeability K_{20} (m/s)

1.43E-09

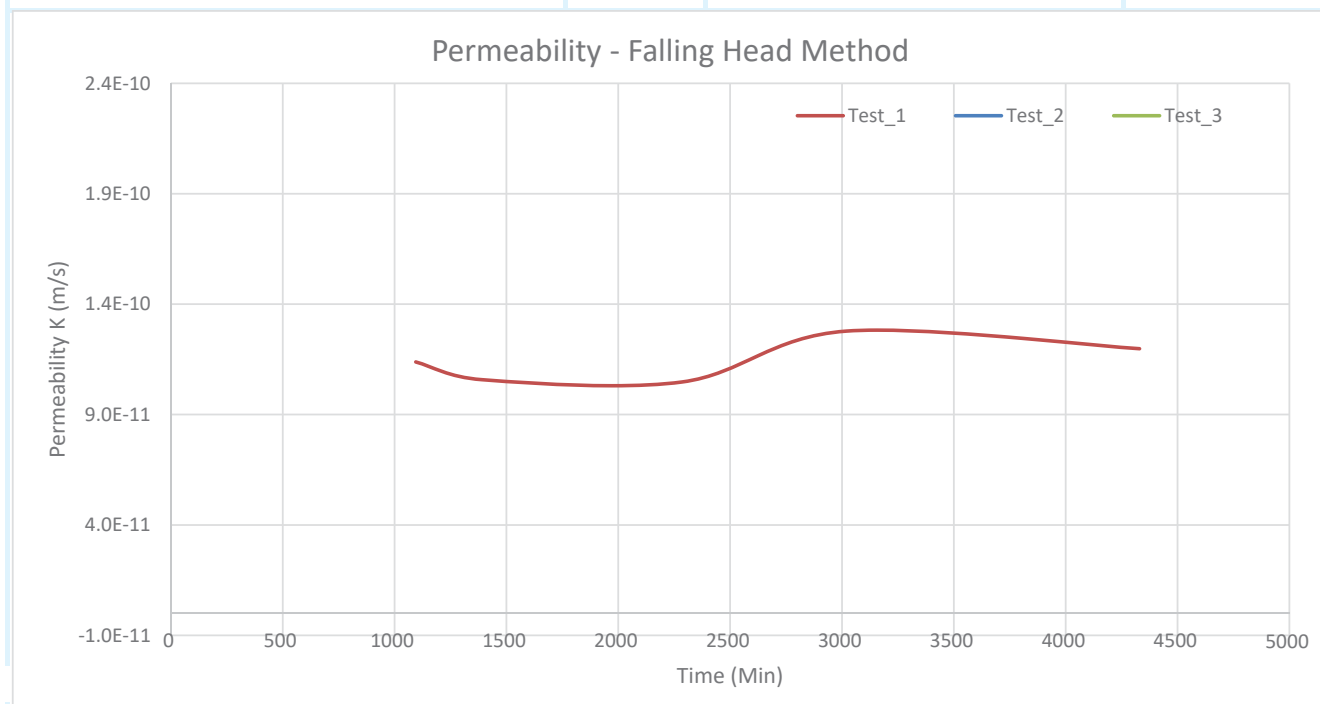
Laboratory Density Ratio (%)	95.2	Laboratory Moisture Ratio (%)	98.8
Compactive Effort	Modified	% Retained on 19mm Sieve	0.0
Surcharge (kPa)	3	Date tested	22/08/2019

Coefficient of Permeability K_{20} (m/s)

1.14E-10
